QC-7002

HONNA MAIN 1.3km

2015 Inspection

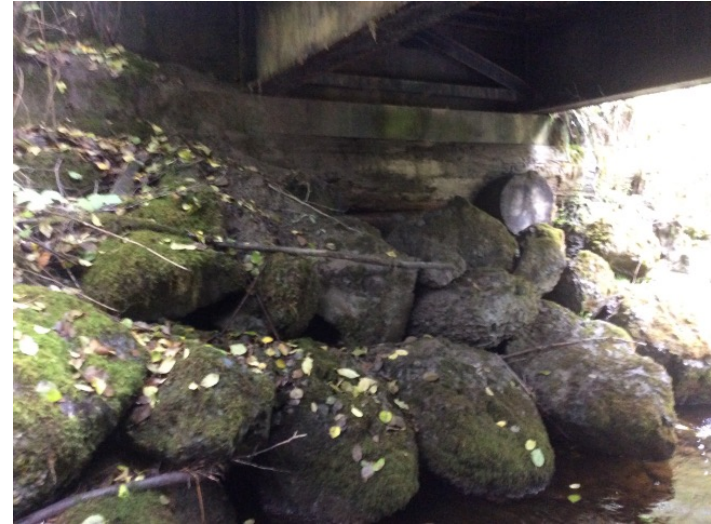
Left Bank Abutment when facing downstream

Log/Timber Cribs **Good**

Tie Backs **Good**

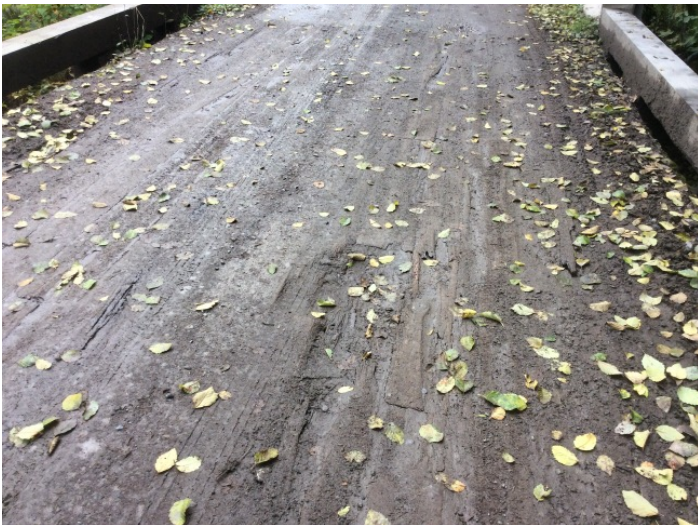
Running Surface	Good	
Running Planks	Poor	Running planks should be replaced
Sub Deck	Good	
Ties	Good	
Nails	Fair	Running plank nail heads starting to be exposed
Deck to Girder Bolts	Good	
Concrete Deck		
Grout Pockets		
Deck Joints		
Steel Deck Plate		
Gravel Surface		
Curb Rail/Blocks/Posts	Good	
Hand Rails/Walkouts		
Hardware		
Overall Deck Condition	Fair	Except for running planks deck is in good condition
Gravel Depth (mm)

Comments: Replace running planks.

Repair Item	Priority	Repair Description
1	Medium	Replace running planks

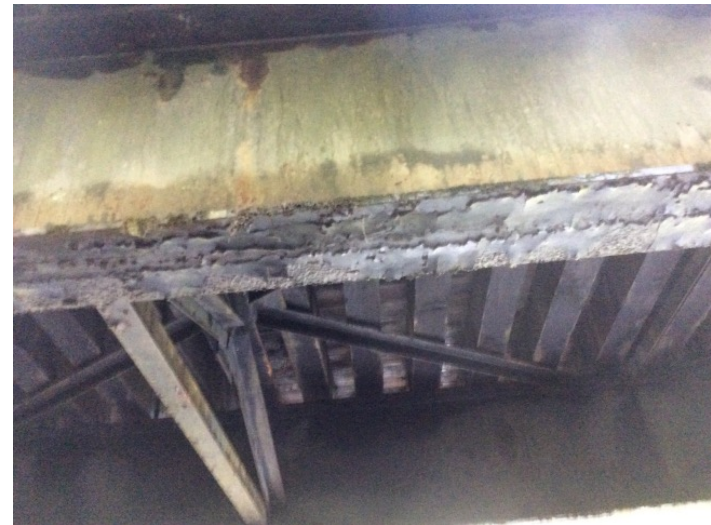
Surface corrosion on bottom girder flange. No cross sectional loss.

surface corrosion on bottom of girder flange
