QC-7007

QC_GLD1000 0.24km

2015 Inspection

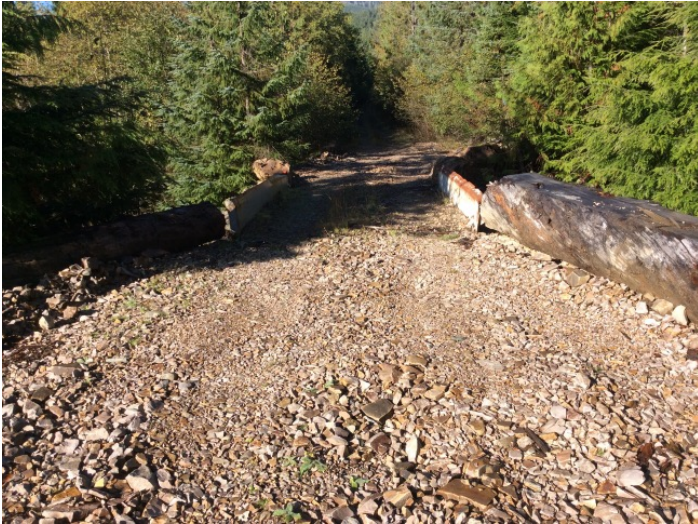
Approach from Right Bank when facing downstream

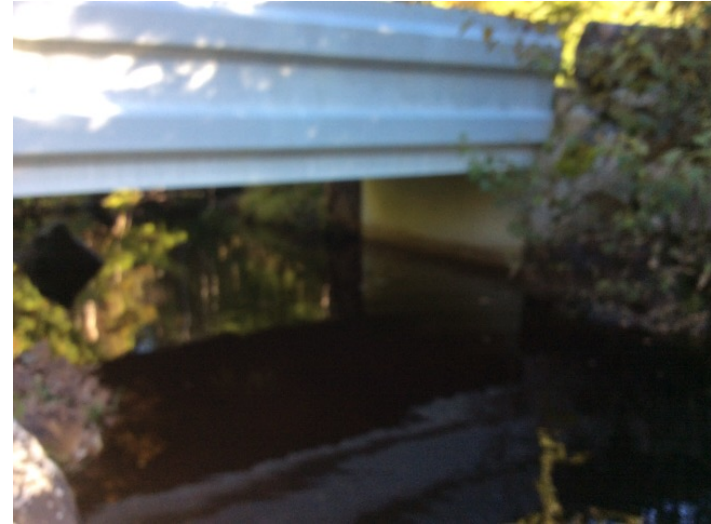
Upstream Profile

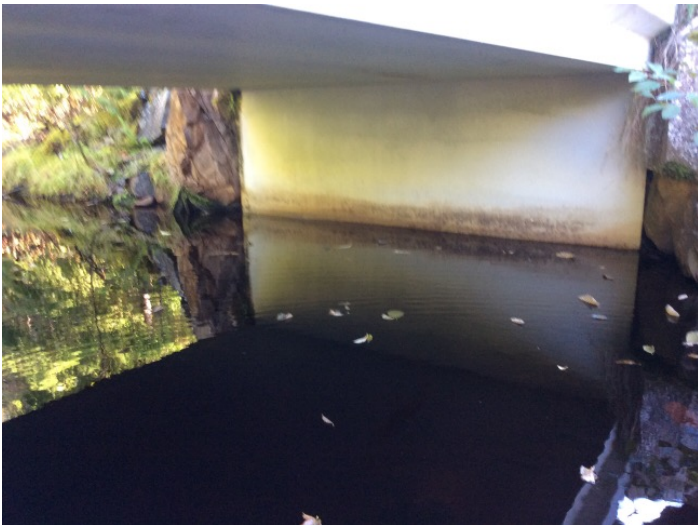
Bin Wall **Good** Steel plate wall abutment. Only able to access face of abutment.

Left Bank Abutment when facing downstream

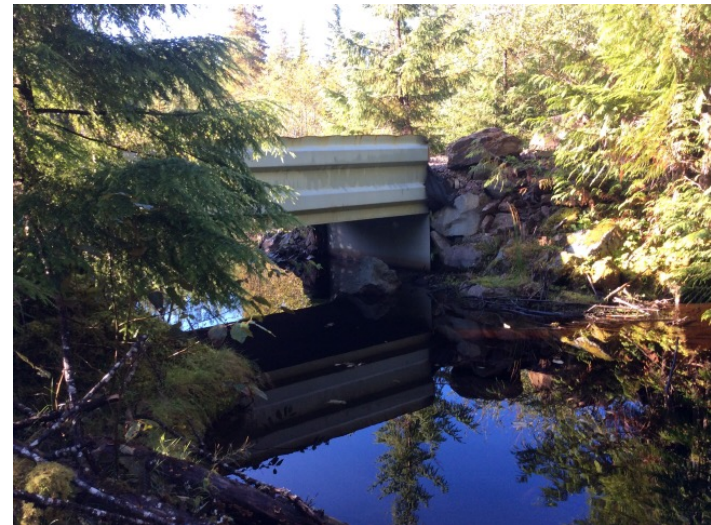
Downstream Profile

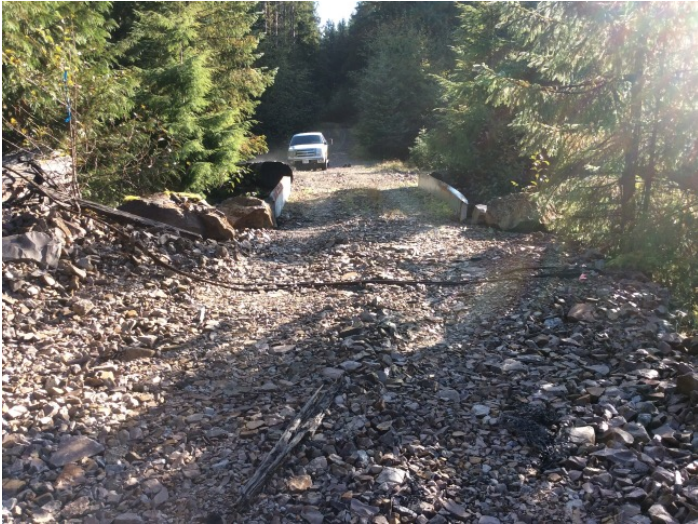
Approach from Left Bank when facing downstream
