QC-7021

HONNA-STANLEY FSR 4.9km

2015 Inspection

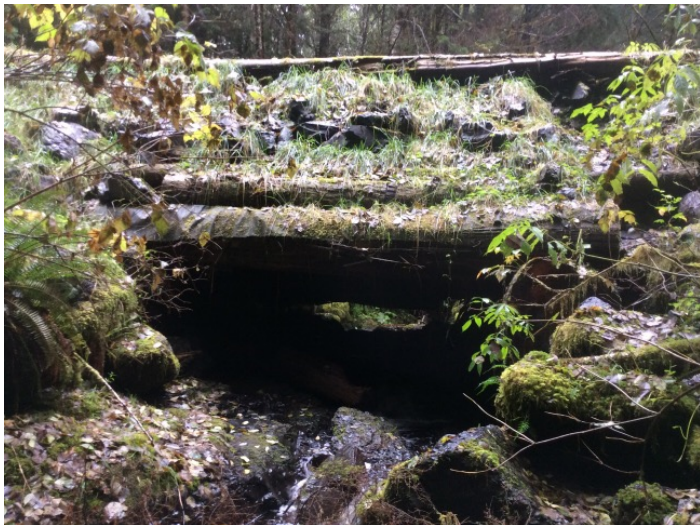
Downstream Profile

Comments scour occurring under left bank sill log on downstream end

| 1 | monitor for scour under sill logs | Annually |
