QC-7023

MORESBY 1.7km

2015 Inspection

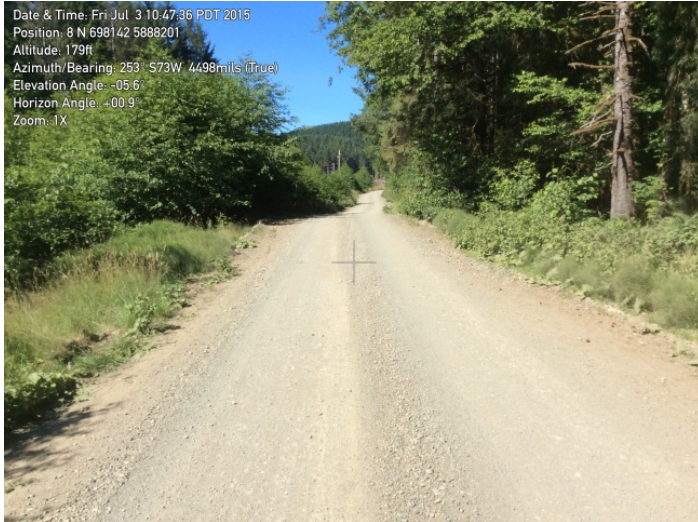
Approach from Left Bank when facing downstream

Brushing Required **Y** **Brush encroaching on road**

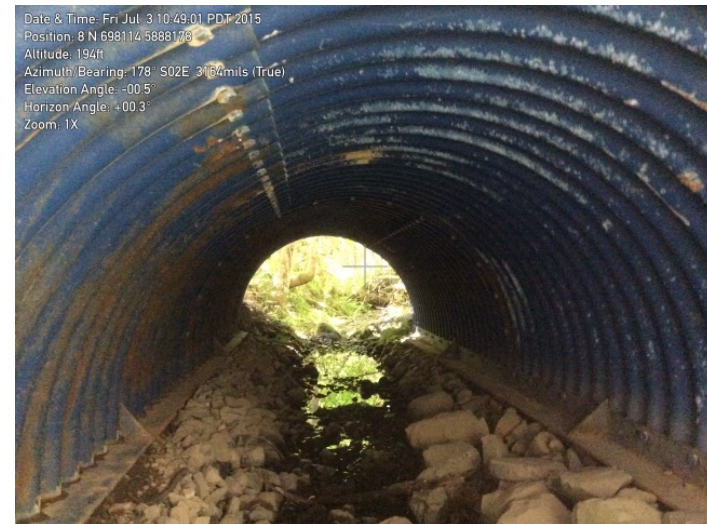
Arch structure

Structure height is 1100mm but height from bottom of creek to top of arch is 1300mm. Fill is leaking down to creek from behind to head walls at all four corners.

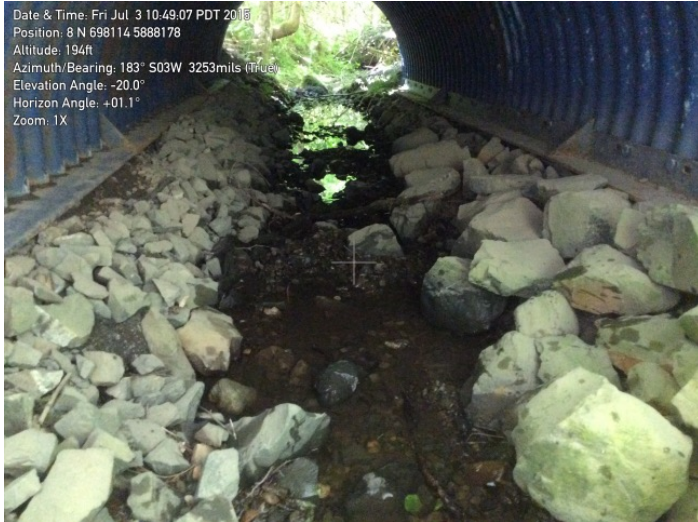
Footings

Comments Risk of scour of footings, very little riprap protection and footings are elevated above stream bed. Small woody debris present.

Item	Monitor Description	Frequency
1	Monitor for scour of footings.	Routine Inspection
2		
3
