QC-7024

MORESBY 1.8km

2015 Inspection

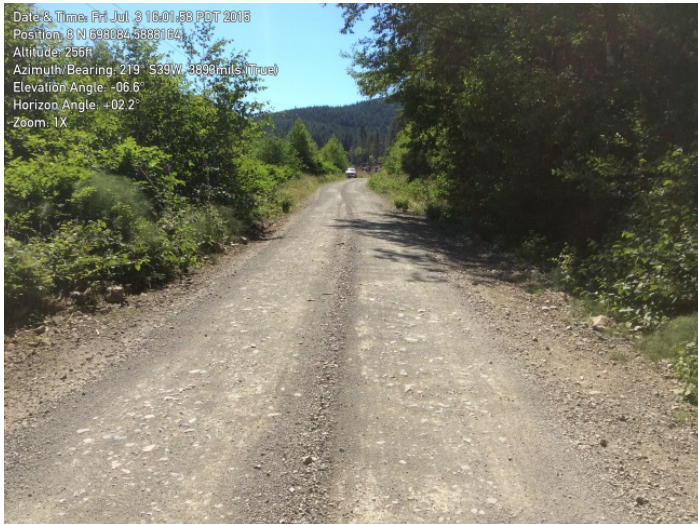
Approach from Left Bank when facing downstream

Brushing Required **Y** **Brush encroaching on road around structure**

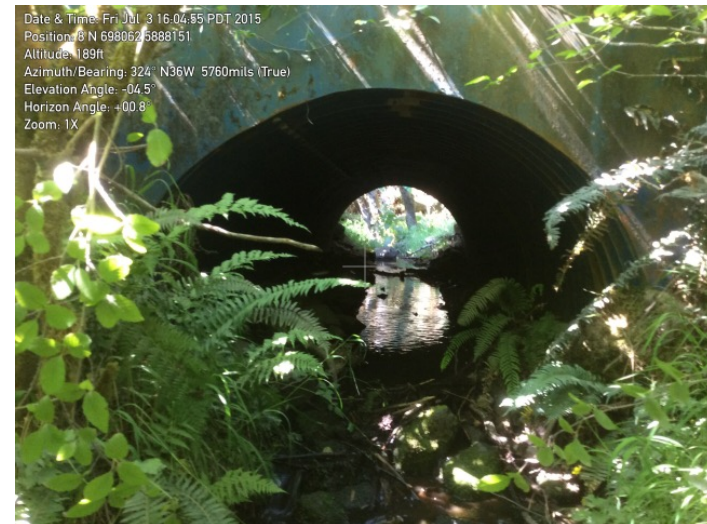
Outlet

Comments Risk of scour of footings. Small woody debris present.

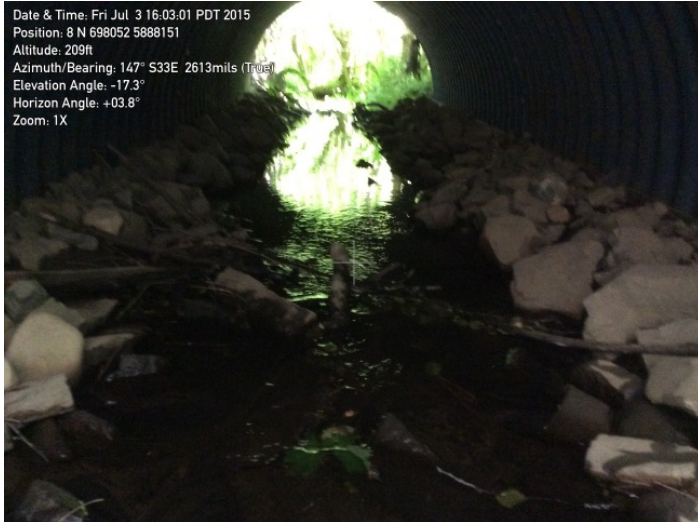
Footings

Baffles	N/A	
Bolted Connections	Good	
Coating	Fair	Painted
Coupled Connections	N/A	
Embedment Materials	N/A	
Fill	Good	Min. Requirement for design load met
Floor		N/A
Footing	Fair	Protected with small riprap, installed at higher elevation than streambed.
Head Walls	Fair	Steel, riprap supporting road fill.
Inlet	Fair	
Outlet	Fair	
Overall	Fair	
Rip Rap	Fair	
Roof	Fair	
Sidewalls	Fair	
Trash Rack	N/A	
Weirs/Backwater Structures	N/A	
Wing Walls	N/A
