QC-7025

MORESBY 3.5km

2015 Inspection

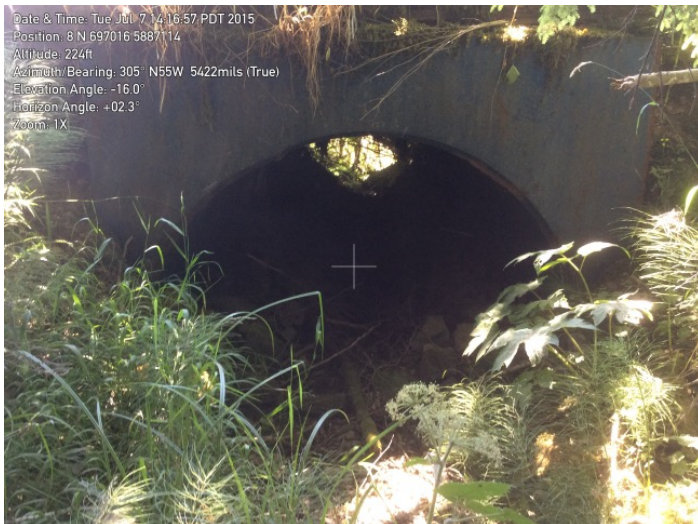
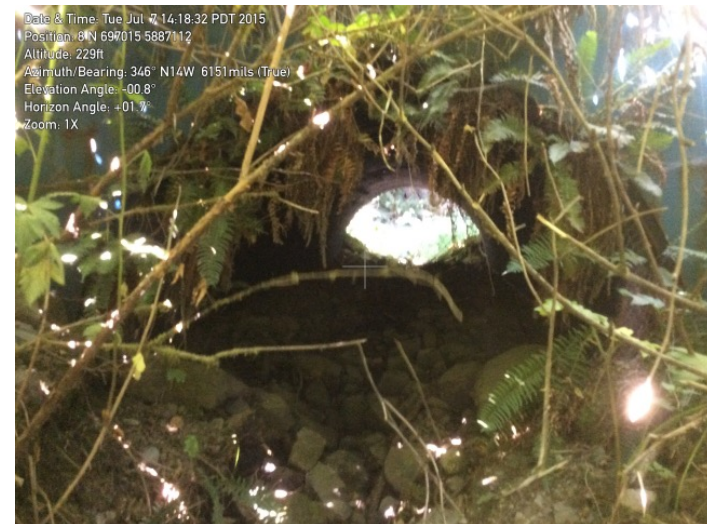
Outlet

Comments Mini-Span IV structure. L-165 min. Cover is 250mm. Fill leaking down to steam from behind headwalls. Stream aggradation downstream of outlet.

Repair Item	Priority	Repair Description
1	Medium	Install riprap below headwalls to support approach fills.
2		
3
