QC-7026

MORESBY 3.8km

2015 Inspection

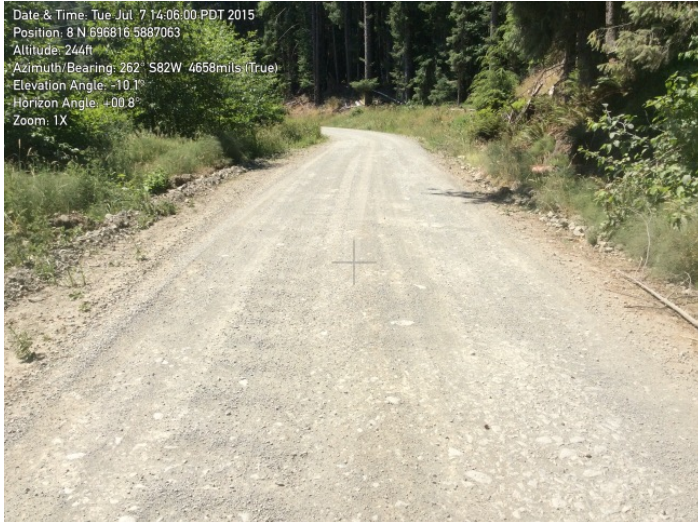
Brushing Required **Y** Rush encroaching on road from around structure

Approach from Left Bank when facing downstream

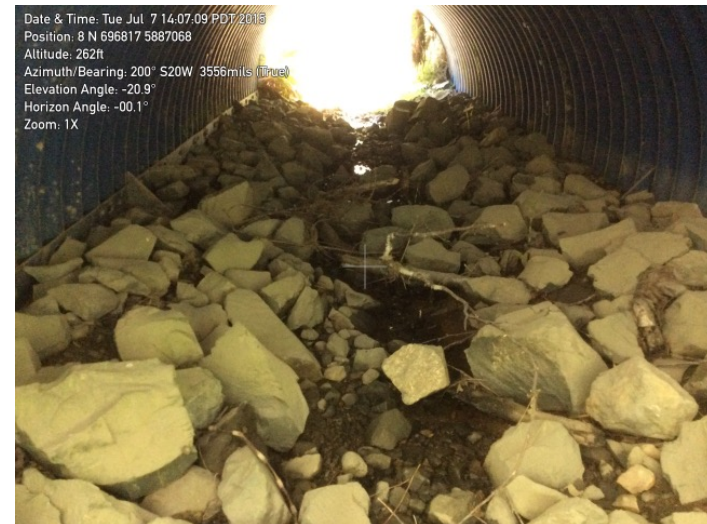
Comments Risk of scour of footings.

Footing riprap

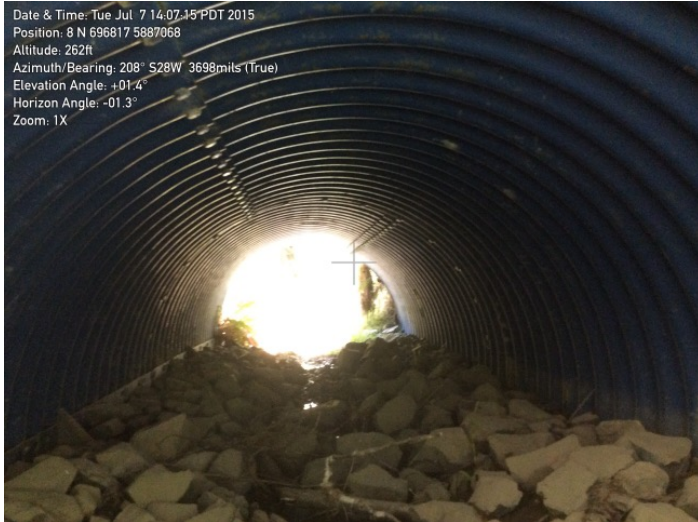
Mini-Span IV structure. Min. Cover for L-165 is 250 mm.

Arch structure

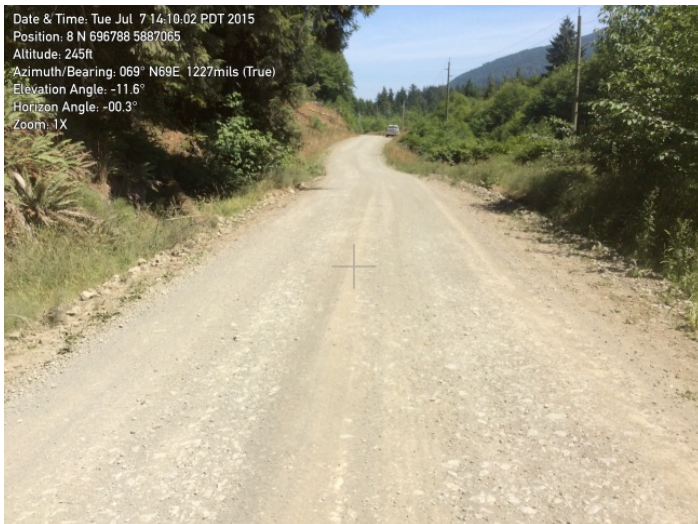
Approach from Right Bank when facing downstream
