QC-7104

BONANZA 8.7km

2015 Inspection

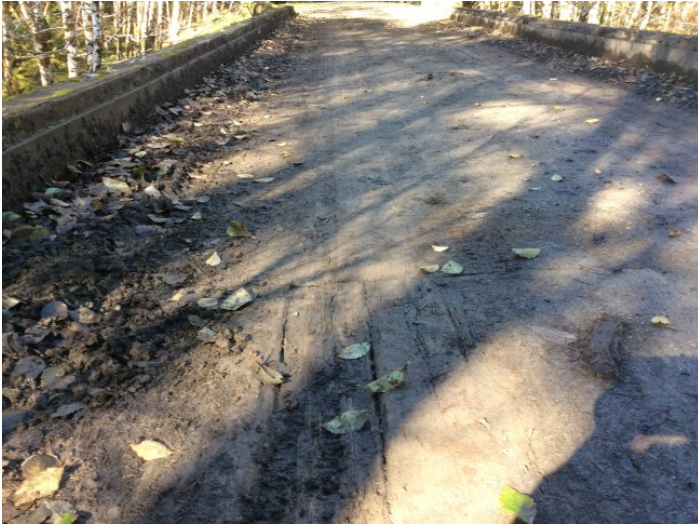
Running Surface	Good	
Running Planks	Fair	Wheel track wear of running planks.
Sub Deck	Good	
Ties	Good	
Nails	Good	
Deck to Girder Bolts	Good	4 deck clips per panel, 2 each side
Concrete Deck	Good	
Grout Pockets	N/A	
Deck Joints	N/A	
Steel Deck Plate		
Gravel Surface		
Curb Rail/Blocks/Posts	Good	
Hand Rails/Walkouts		
Hardware		
Overall Deck Condition	Good	
Gravel Depth (mm)

Repair Item	Priority	Repair Description
1	High	Replace running planks
