QC-7105

HANGOVER 10.7km

2015 Inspection

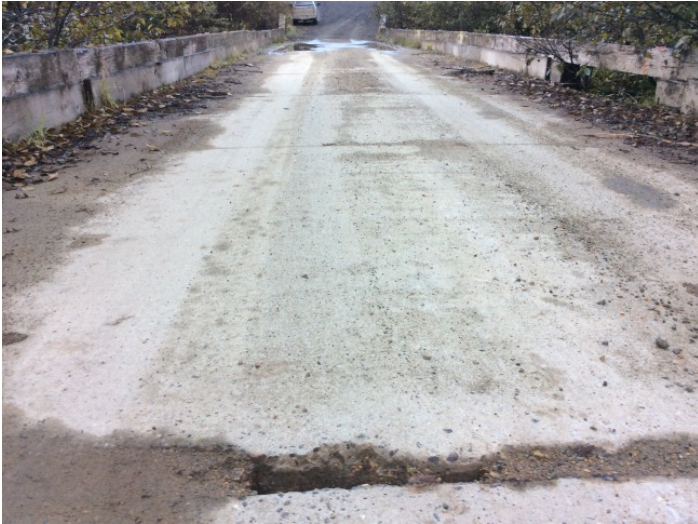
Running Surface	Good	
Running Planks		
Sub Deck		
Ties		
Nails		
Deck to Girder Bolts		
Concrete Deck	Good	
Grout Pockets	Good	
Deck Joints	Good	At both ends of bridge deck, end of deck panel damaged, leaving small gap between deck and ballast wall approx 50mm x 500mm long.
Steel Deck Plate		
Gravel Surface		
Curb Rail/Blocks/Posts	Fair	Timber Guardrails nearing end of service life.
Hand Rails/Walkouts		
Hardware		
Overall Deck Condition	Good	
Gravel Depth (mm)

Comments: Repair deck panels. Guardrails nearing end of service life, plan on replacement in next few years.
