QC-7108

BONANZA 18.1km

2015 Inspection

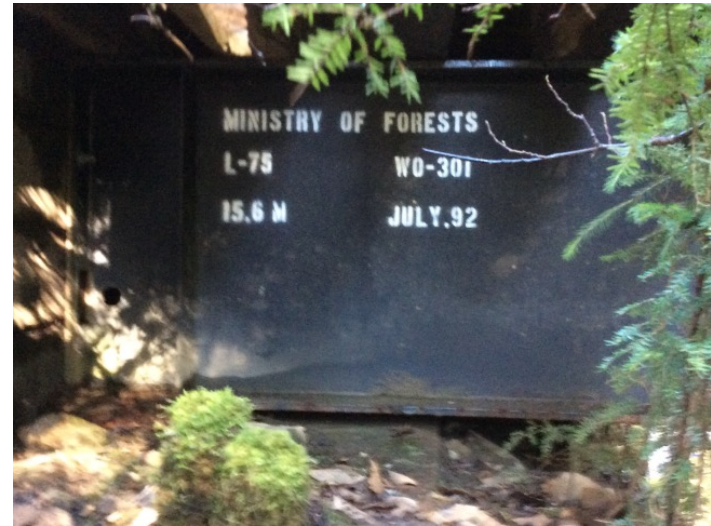
Structure ID

Serial/ID Plate Rapidspan. WO-301 L-75. July/92

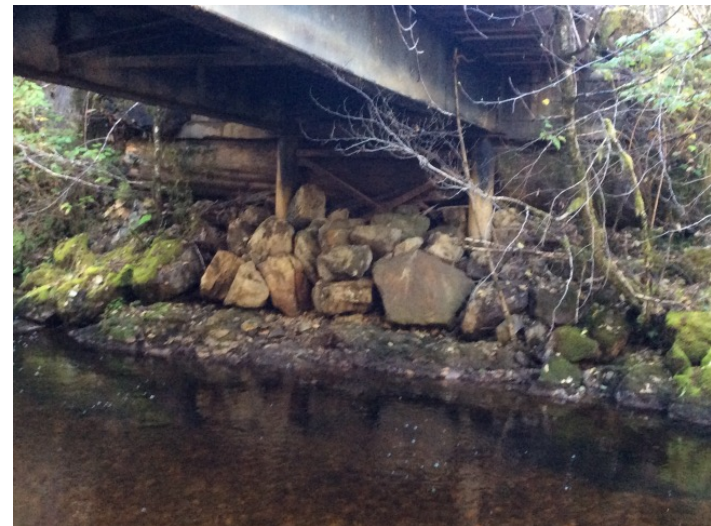
Left Bank Abutment when facing downstream

Piles or Posts **Good** Left bank

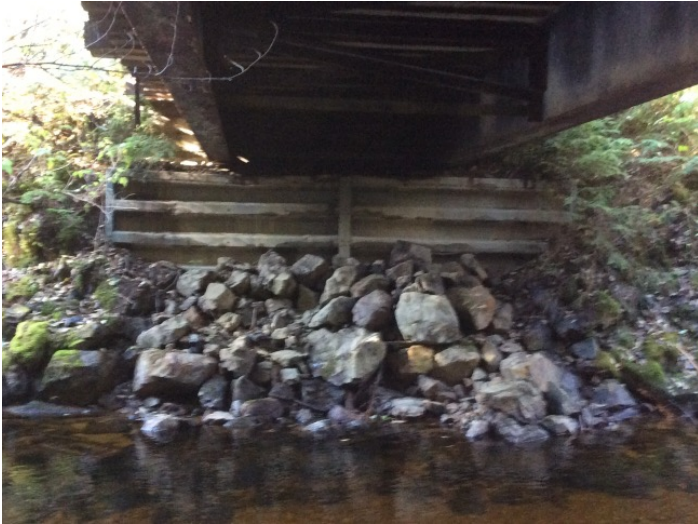
Right Bank Abutment when facing downstream

Bin Wall **Good** Right bank

Caps or Sills **Good** Precast concrete sill on bin wall
