QC-7112

BONANZA 20.7km

2015 Inspection

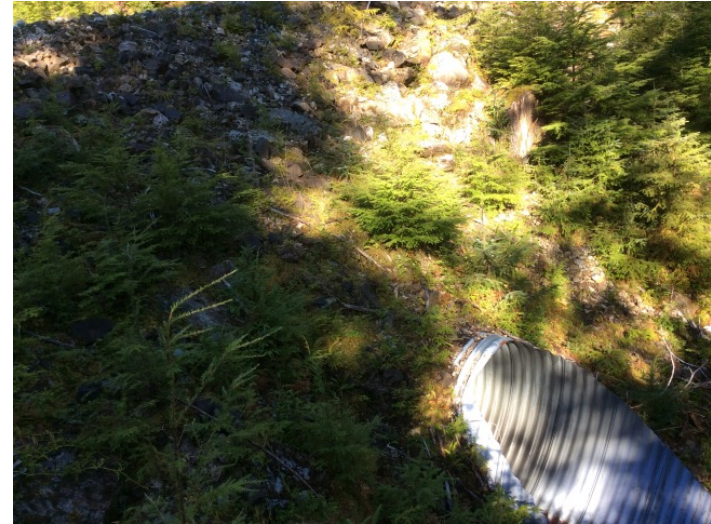
Downstream Profile

Fender Condition **No guide logs**

Consider installing guard logs on downstream side.

Comments: Install fender logs.
