QC-7701

HANGOVER 2.4km

2015 Inspection

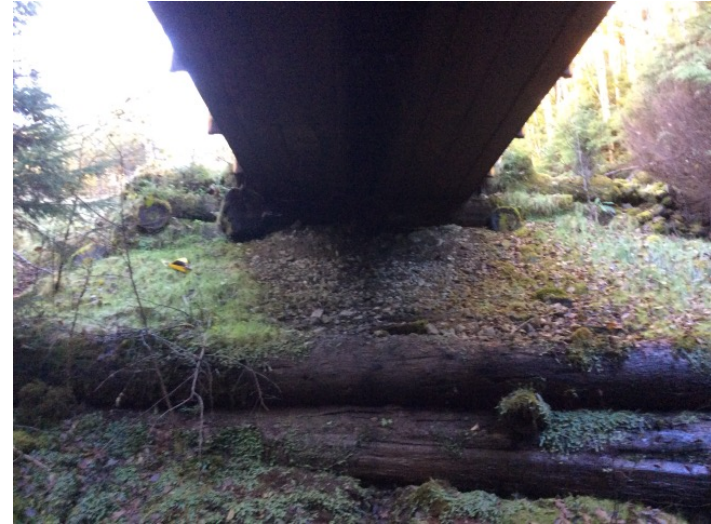
Right Bank Abutment when facing downstream

Riprap Poor No riprap supporting stream banks. Crib logs from previous structure supporting toe of slope below abutments.

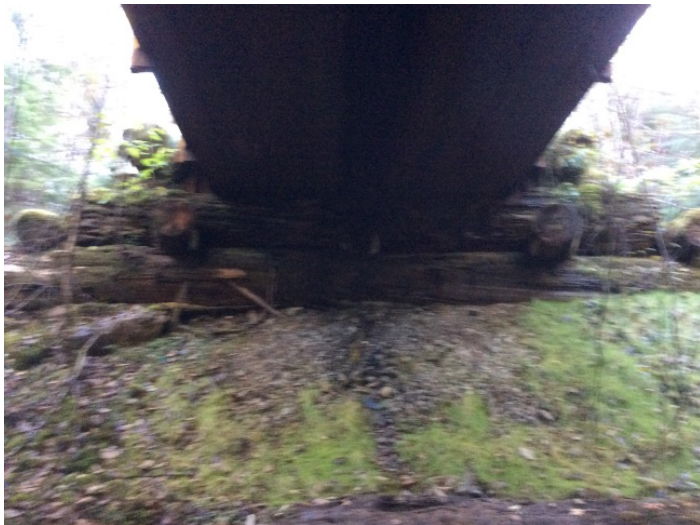
Left Bank Abutment when facing downstream

Log/Timber Cribs Good 2 high cedar log cribs.

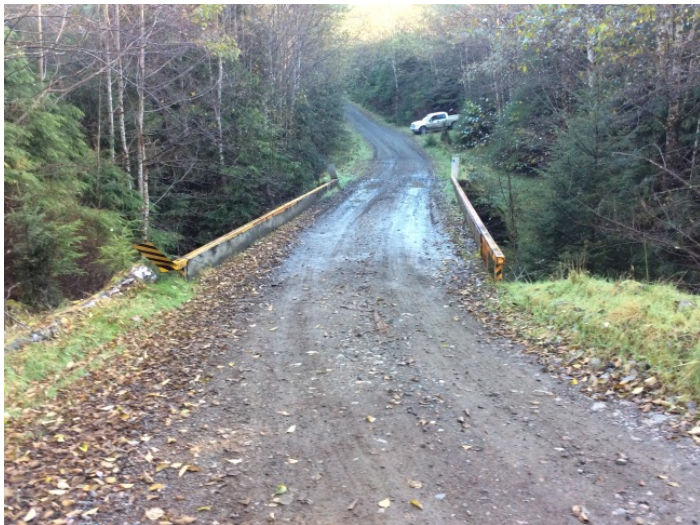
Approach from Right Bank when facing downstream

Alignment Fair Short radius turn off right bank approach.

Fender Condition Fair Advanced rot in guide logs. Berm on right bank downstream side.
