QC-7803

LOON SOUTH FSR 2.8km

2015 Inspection

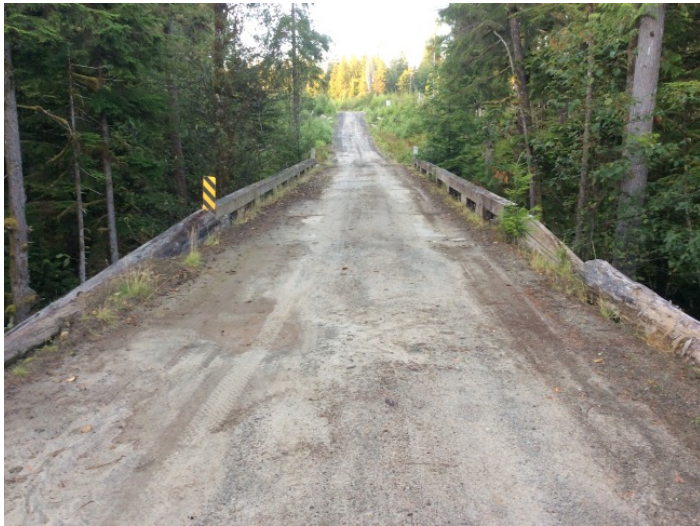
Approach from Right Bank when facing downstream

Fender Condition **Poor** **Guide logs have been pushed off road, likely by grader.**

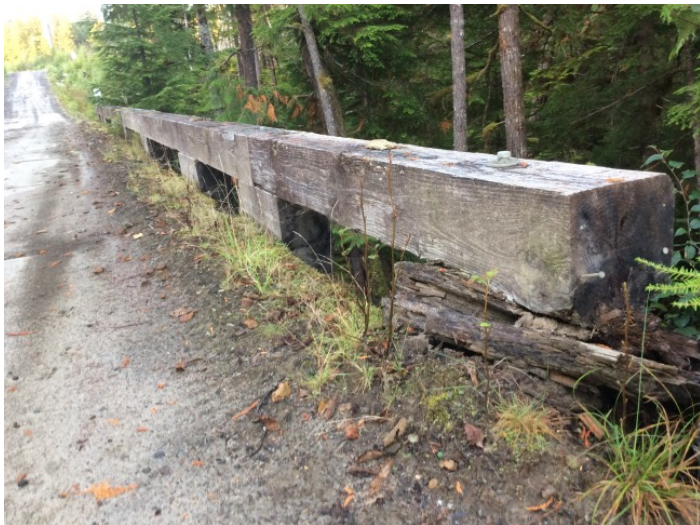
Guard Rail

Running Surface	Good	
Running Planks		
Sub Deck		
Ties		
Nails		
Deck to Girder Bolts	Good	
Concrete Deck	Good	
Grout Pockets	N/A	
Deck Joints	Good	
Steel Deck Plate		
Gravel Surface		
Curb Rail/Blocks/Posts	Poor	Extensive rot in Guardrails and connecting blocks.
Hand Rails/Walkouts		
Hardware		
Overall Deck Condition	Good	
Gravel Depth (mm)
