QC-7833

QC_MOS1000 3.7km

2015 Inspection

Latitude	Longitude		
53°4'5"	-132°11'6.3"		
Crossing Name	Jovo Creek		
FSR #	10247	Branch #	1
Road Name	QC_MOS1000		
User km	3.7		
Current Load Rating (tonnes)	30		
Structure Class	Temporary Bridge		
Portable	N		
Superstructure	Log Stringers		
Deck Type	Gravel		
Abutment Left	Crib, Log or Untreated Timber		
Abutment Right	Crib, Log or Untreated Timber		
Spans	1		
Total Length (m)	11		
Deck Width (m)	4.3

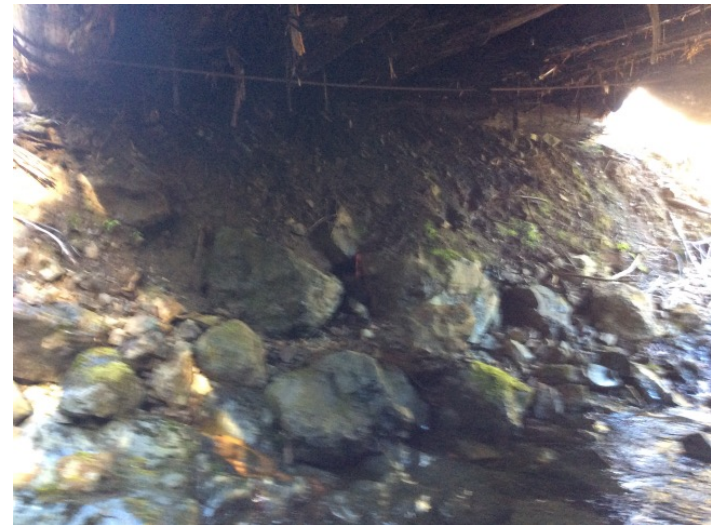
Left Bank Abutment when facing downstream

Single sill logs embedded in stream bank. Some scour of fill below left bank at up stream end and at downstream end. Stream bank bedrock controlled below fill.

Comments Risk of scour on left stream bank.

Repair Item	Priority	Repair Description
1	High	Post reduced load rating on sign.
2	High	Replace stringer #7
3	Medium	Add additional riprap along left bank.

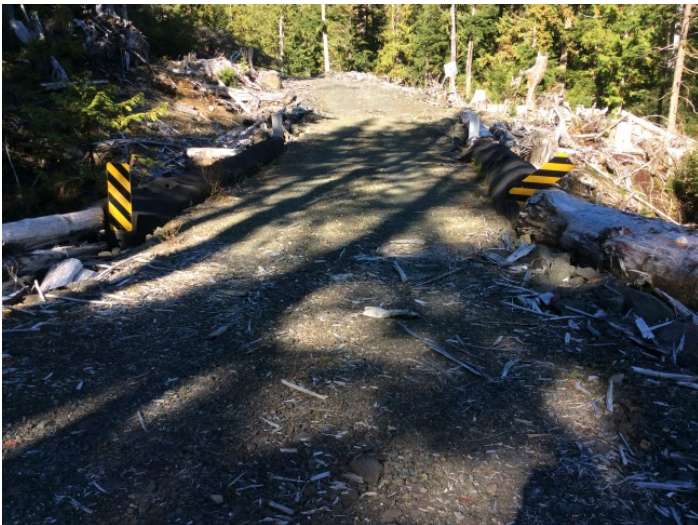
Approach from Right Bank when facing downstream

Turn off right bank approach and abrupt raise in grade 10 m back.
