QC-7900

BONANZA/BILL BROWN 5.3km

2015 Inspection

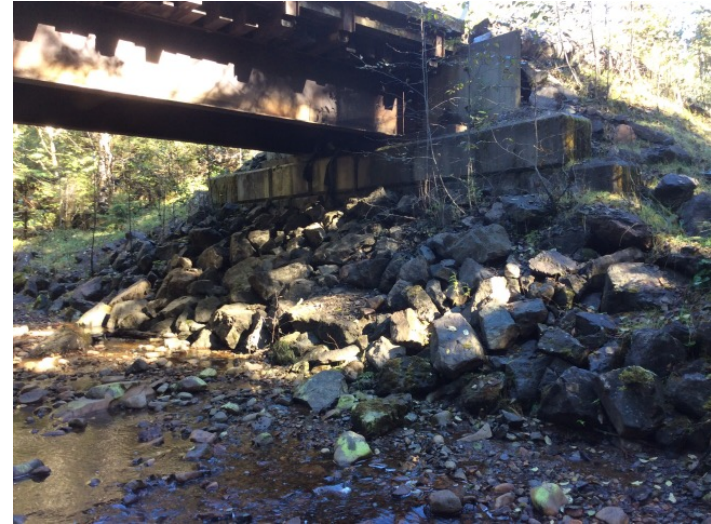
Left Bank Abutment when facing downstream

Concrete **Good** Lock blocks

Caps or Sills **Good** CCA Treated timber sills, lag bolt connections to girder

Ballast Wall **Good** precast concrete

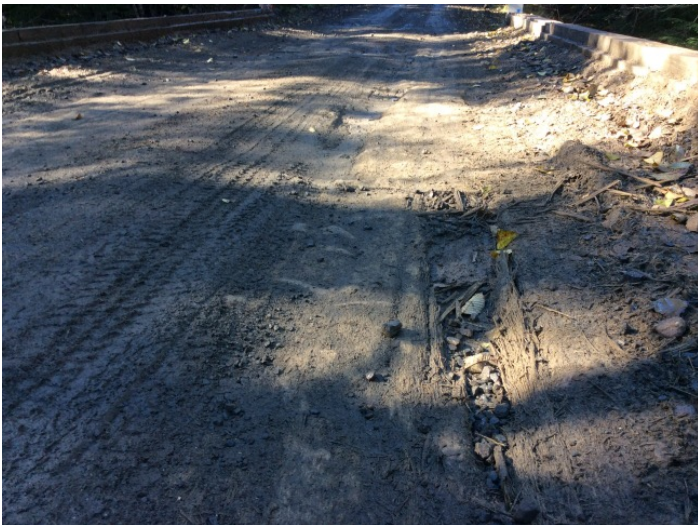
Replace running planks. Sub-deck and cross ties in good condition.

Running Surface	Good	
Running Planks	Poor	Running planks under wheel tracks are worn. Several short sections missing.
Sub Deck	Good	
Ties	Good	
Nails	Good	
Deck to Girder Bolts	Good	6 bolt per deck panel, 3 per side
Concrete Deck		
Grout Pockets		
Deck Joints		
Steel Deck Plate		
Gravel Surface		
Curb Rail/Blocks/Posts	Good	
Hand Rails/Walkouts		
Hardware		
Overall Deck Condition	Good	
Gravel Depth (mm)

Comments: Replace running planks.
