QC-7905

QC_MOS1000 2.3km

2015 Inspection

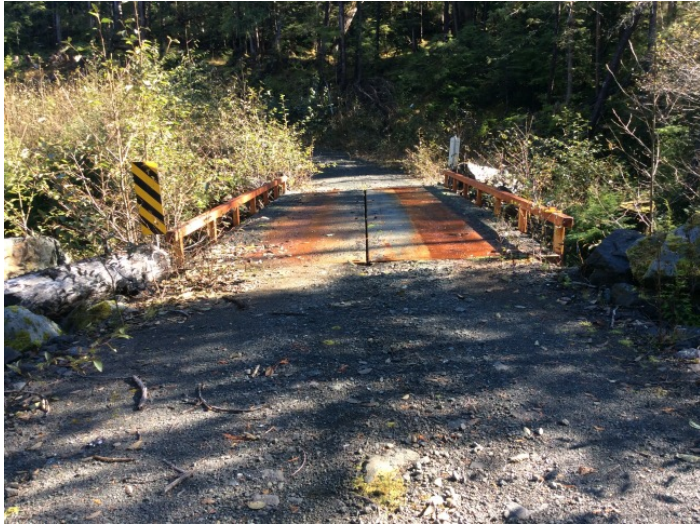
Approach from Left Bank when facing downstream

Brushing Required **Y**

Delineator Missing Left 0 1 2

Delineator Missing Right 0 1 2

- 1 Low Replace two missing delineators.
- 2 Low Clear brush encroaching on bridge.

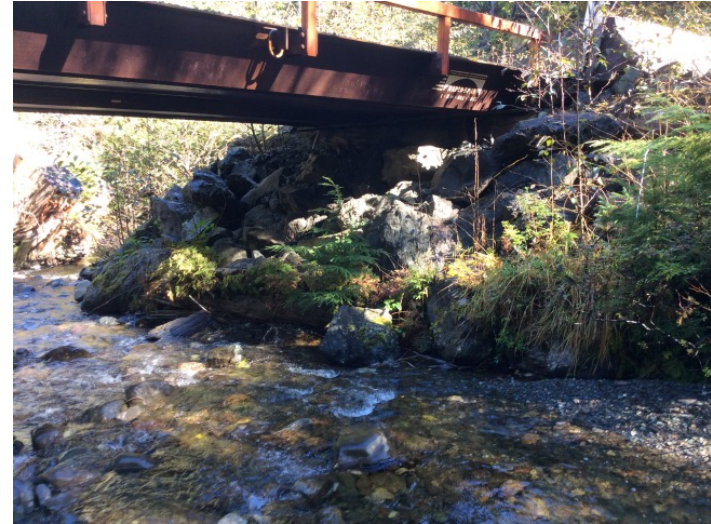
Right Bank Abutment when facing downstream

Steel Deck Plate **Good** 100mm gap between deck sections on right bank. Bridge sections are chained together.

Comments Bridge on 2% grade from left bank to right. 100mm gap between bridge sections on right bank. Bridge sections are chained together.

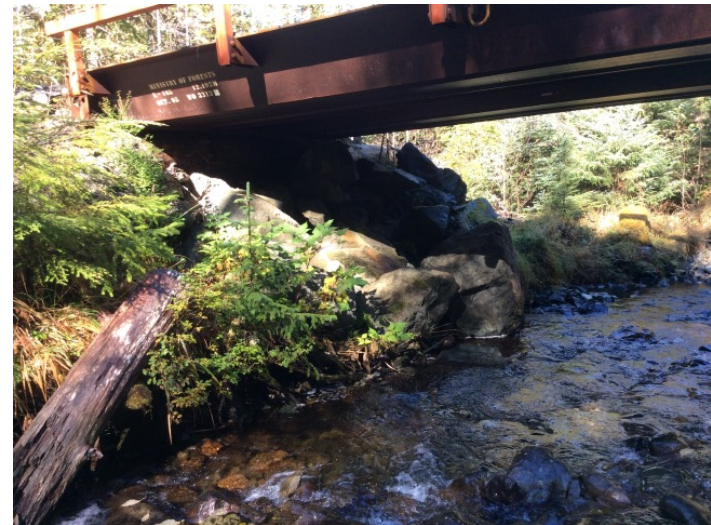
Left Bank Abutment when facing downstream

Ballast Wall **Fair** Some rot with log ballast logs. Functioning OK.

Bearings **Fair** Sill logs flat dressed but lag bolts only on outside sections.
