## APPENDIX A

### Incomappleux Rd Bridge Deactivation Prescription

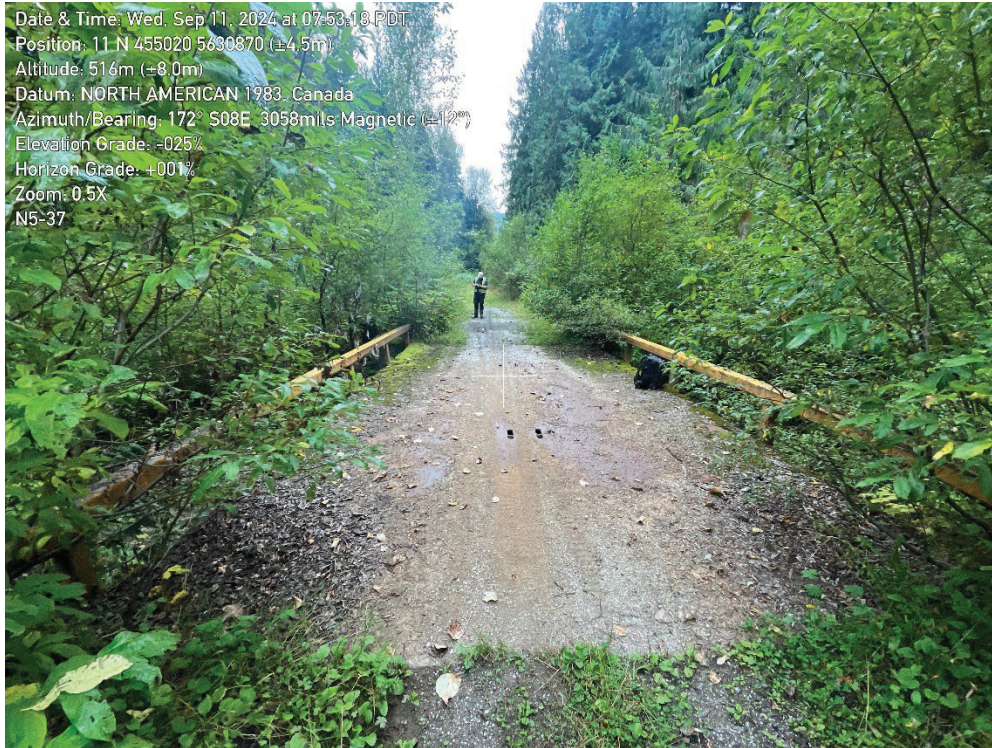
**Description:** 8 m steel structure with attached steel deck. Guard rails are steel and are bolted on. There are 14 lock blocks to be removed: 7 on each side. The bridge sits on a single creosote tie on top of the lock blocks on each end. Creosote ties will need to be removed to an approved facility for disposal. There are cut holes in the bridge deck that can be used to lift and remove. Adjacent area is very flat with lots of room for machines to work. No danger trees for removal at the time of assessment.

Overview of Bridge N5-037. Note the cut holes in the deck for machine lift.

**Equipment Requirements:** Bridge could easily be removed with one 200 or 300 series excavator.

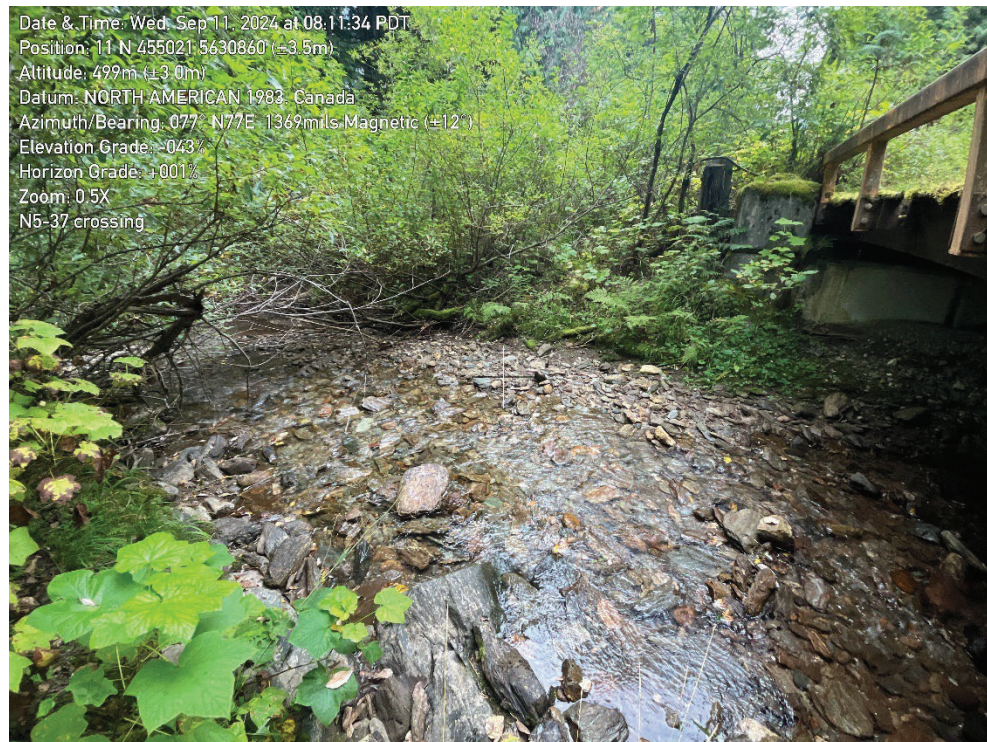
**Wet Crossing:** Easy crossing expected due to low flow in stream channel. Best crossing option is on low side where streambed is covered in rock and would result in very little disturbance and sediment transfer.

Easy wet crossing location with flat streambanks and rocky substrate.

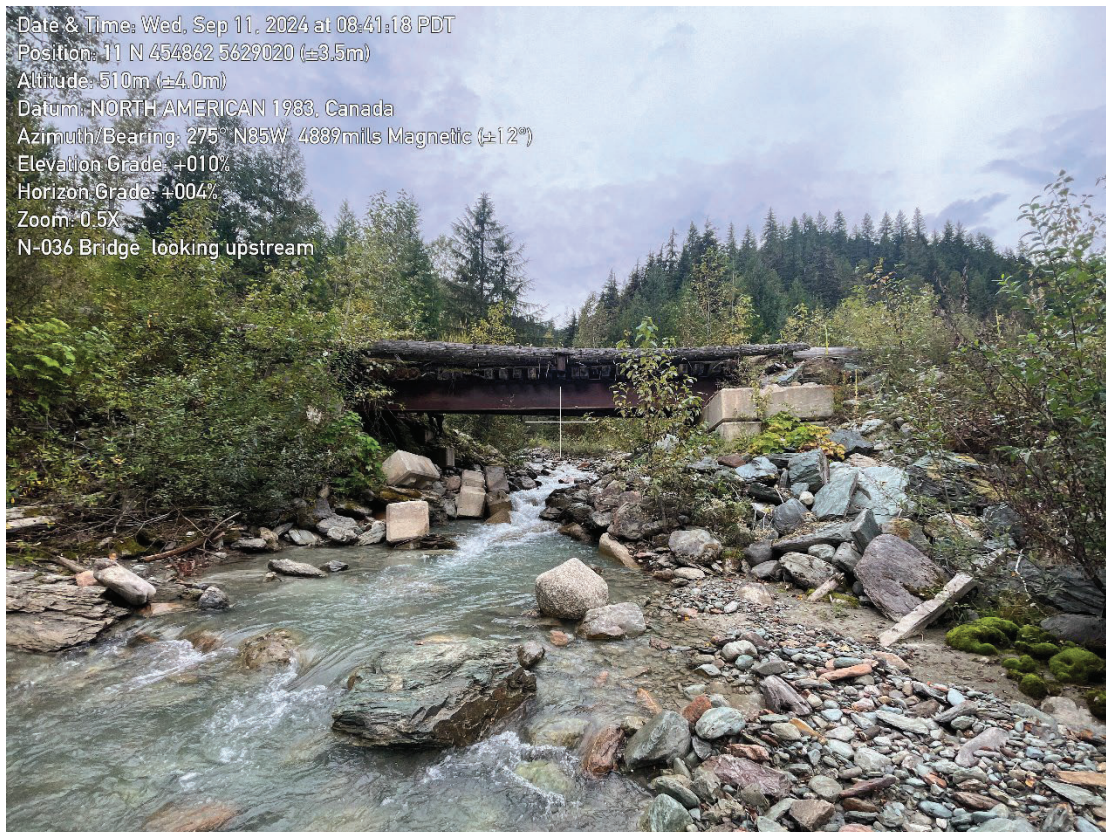
Overview of N5-036 bridge looking upstream.

**Equipment Requirements:** A 200 and 300 series hoe are required for removal.

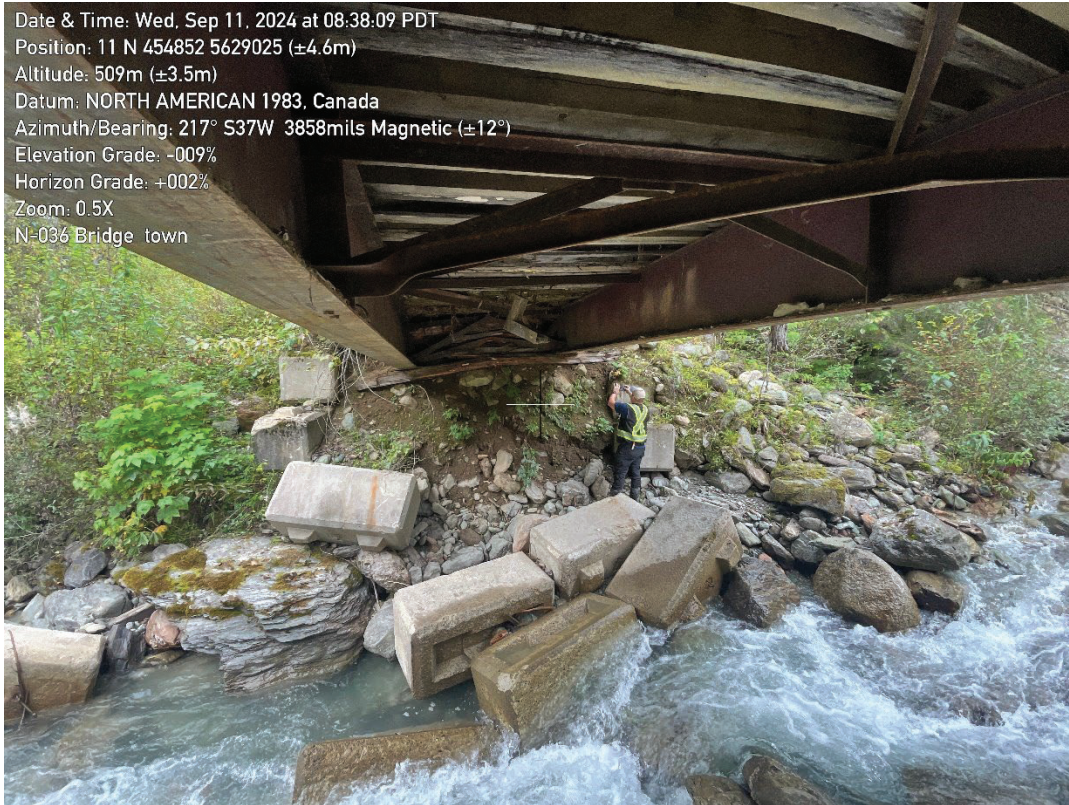
**Description:** 12 m steel structure. Cross ties and decking are wooden, with a layer of gravel over top. Lock blocks on the town side have collapsed and there is no longer an abutment there. There is a noticeable twist in the bridge due to abutment failure but will likely take on its original form once removed. Some steel cross ties on the underside are bent and one has broken off. There are 28 lock blocks total for removal: 14 each side. Seven are sitting in the stream. The lock blocks could be used to put a barrier on either side of the removed crossing with signage for safety.

Twisting of bridge structure due to abutment failure on town side.

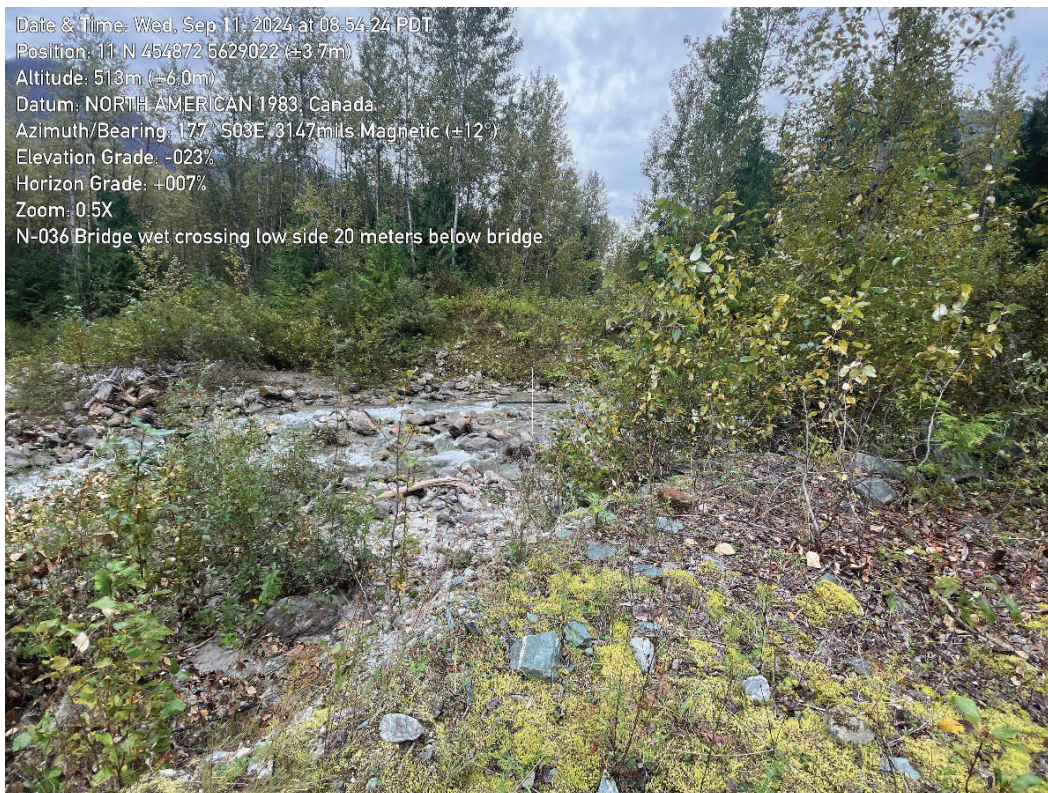
**Wet Crossing:** Designated crossing possible 20 meters downstream. Channel substrates are comprised of large boulders and machine can cross without causing significant disturbance. Adequate rock and material available on the bush side for armouring and stream rehabilitation. No danger trees for removal at the time of assessment.

Wet crossing location 20 m downstream of bridge. Substrate here is ideal for limiting disturbance to streambed.

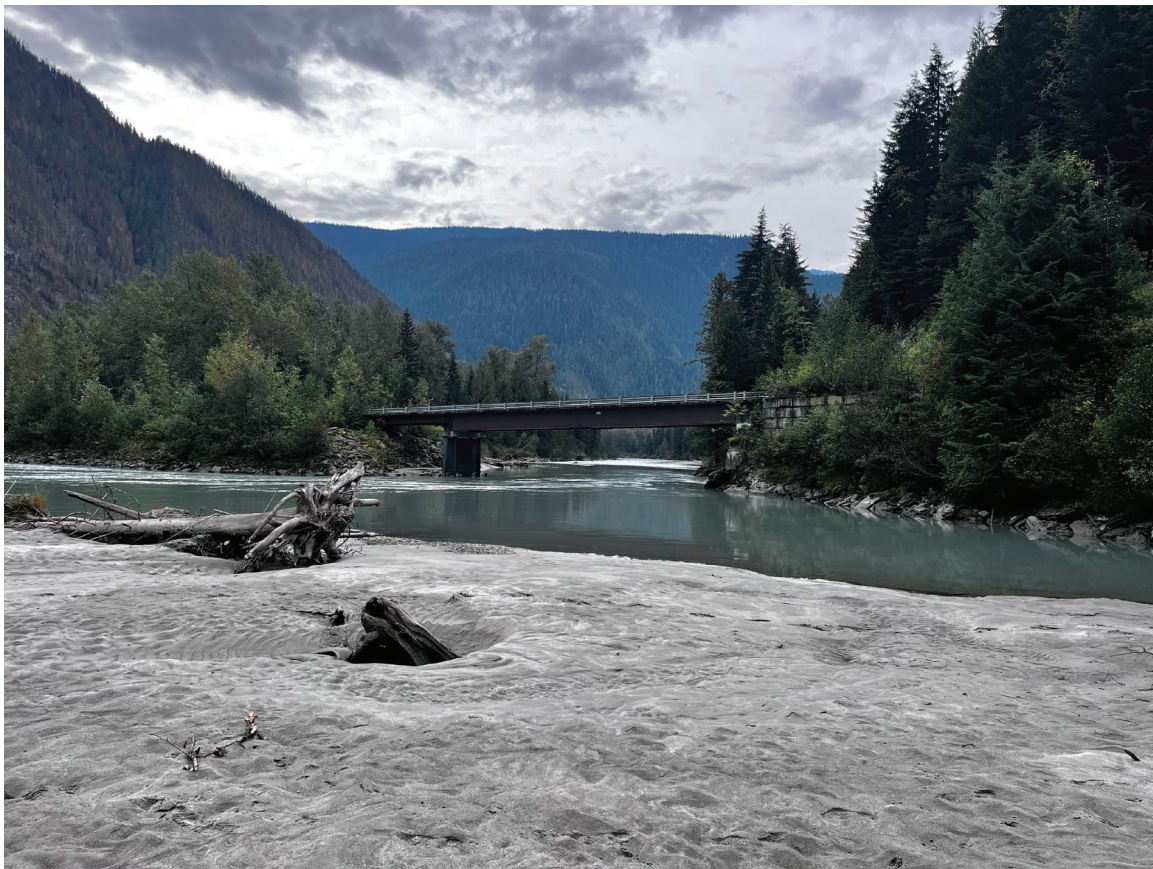
**Description:** 30 m steel structure that remains in very good form and is not scheduled for replacement until 2054. Abutments and structures are in good condition with only one small dent on the upstream guard rail. Decking is made of 15 grouted concrete panels. There is little concern with stream effects as there is more than adequate armouring on town side and on bush side the river butts up against bedrock. There are approximately 24 lock blocks forming an additional wall on the bush side and is providing stability to contain the road fill. Although removal is not considered critical at this time, other deactivation occurring on section 1 towards town would limit any access to this bridge site in the future.

Bridge N5-035. Looking downstream. Bush side lock block wall visible on the right.

**Equipment Requirements:** This bridge was likely installed using a crane. Crane access is more limited now due to bridges ratings towards town. A detailed removal plan was being looked at by MoF Engineering staff. This information was unavailable at the time of this draft

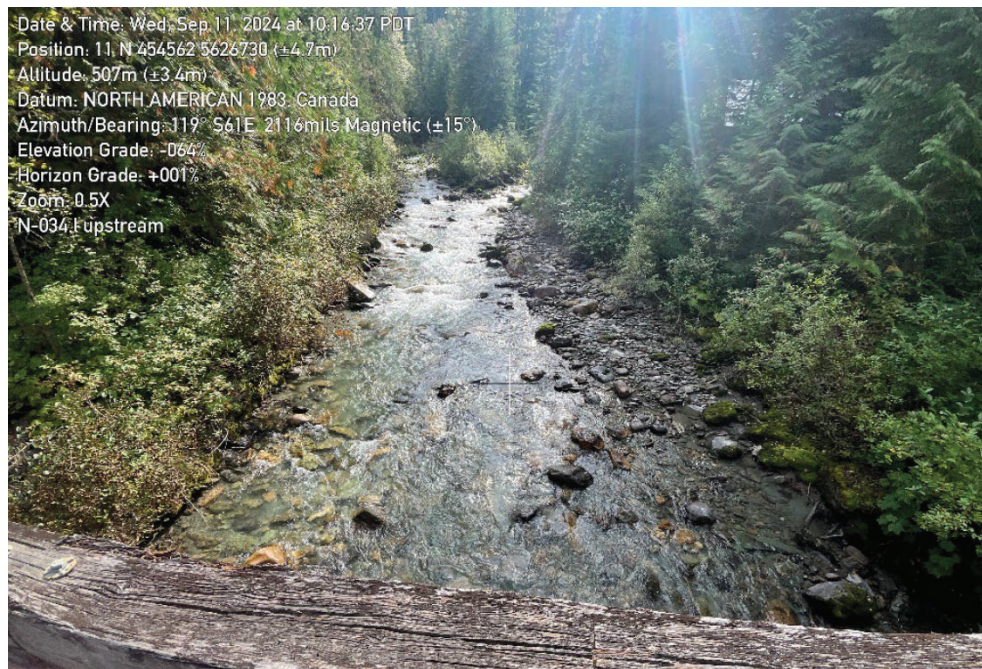
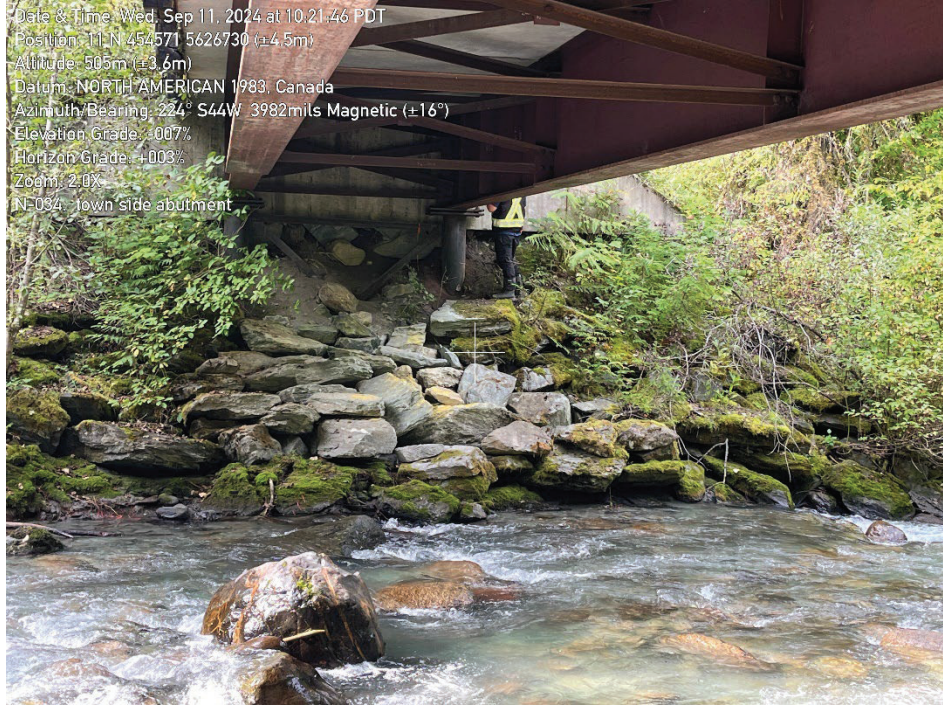
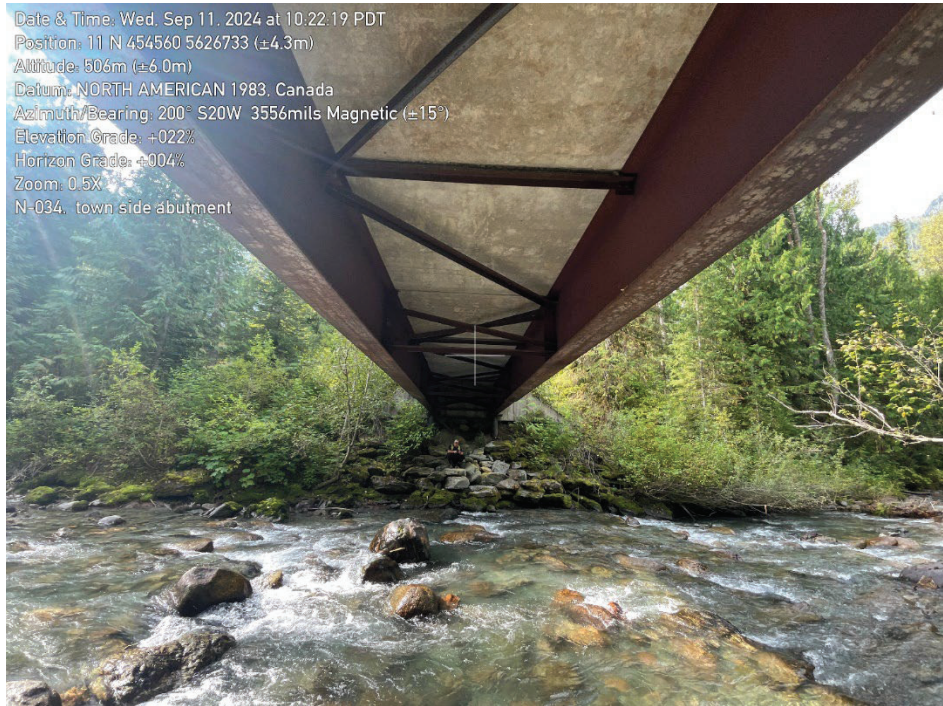
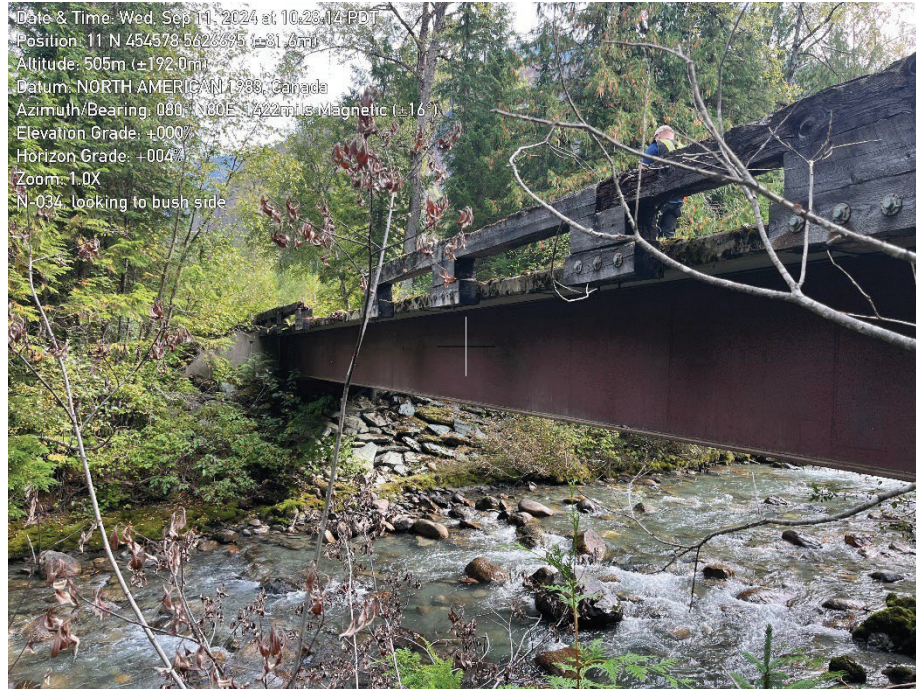
## Bridge 4: N5-034

**Description:** 24 m steel structure with steel pilings and bolted to a concrete abutment wall. There are 10 side mounts on each side for the guard rails, each held by 3 bolts driven into concrete. Plenty of material on site for armouring and wet crossing. Stream edge will not require any rehabilitation as width and armouring is adequate under the bridge and is exhibiting natural flow patterns. Bridge deck is concrete panels. New guard rails would likely be required for access beyond this bridge during deactivation works.

**Wet Crossing:** Private Land??? Good crossing on the downstream side with side banks approximately 2 m high. Streambed is made up of 10cm to 1 meter size rocks with the average size being 30cm cross section width. There is a good landing at the road junction for equipment. No danger trees for removal at the time of assessment, however several large cottonwoods are adjacent to the work area and will need re-assessment at the time of the bridge deactivation.

**Equipment Requirements:** One 200-series hoe and one 300-series hoe.
