SC-8015  
SC-8015

## DUCK LAKE 12.2km

2025 Inspection

Crossing Name Sweetwater Creek

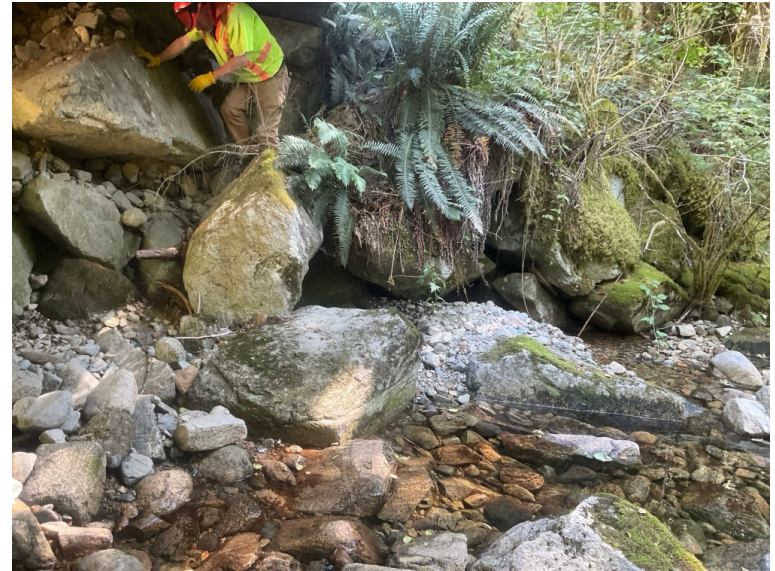
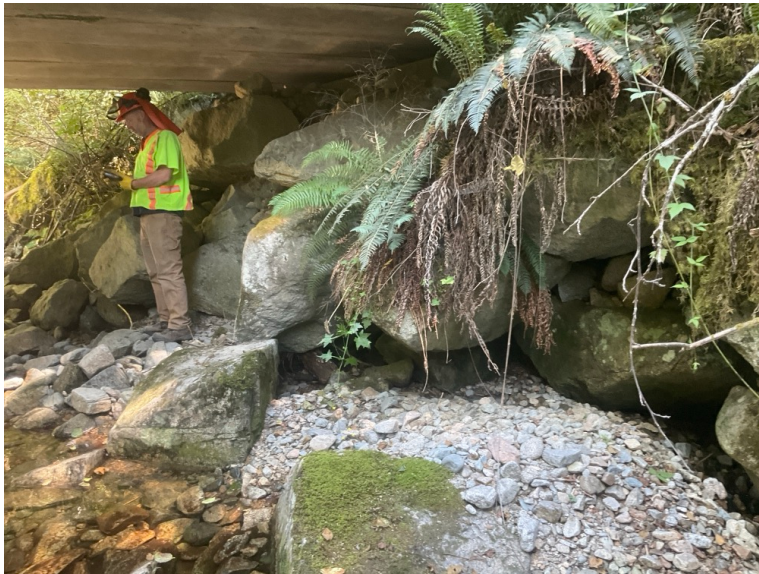
Left Bank Abutment when facing downstream

Riprap **Fair** Scoured left side. Large, unsorted riprap. Monitor.

Consider adding riprap on ds left side, or monitor.

| Item | Monitor Description | Frequency |
|---|---|---|
| 1 | Monitor riprap | Routine Inspection |
