SC-8051  
SC-8051

MCNAIR 0.8km

2025 Inspection

Crossing Name Dakota Creek

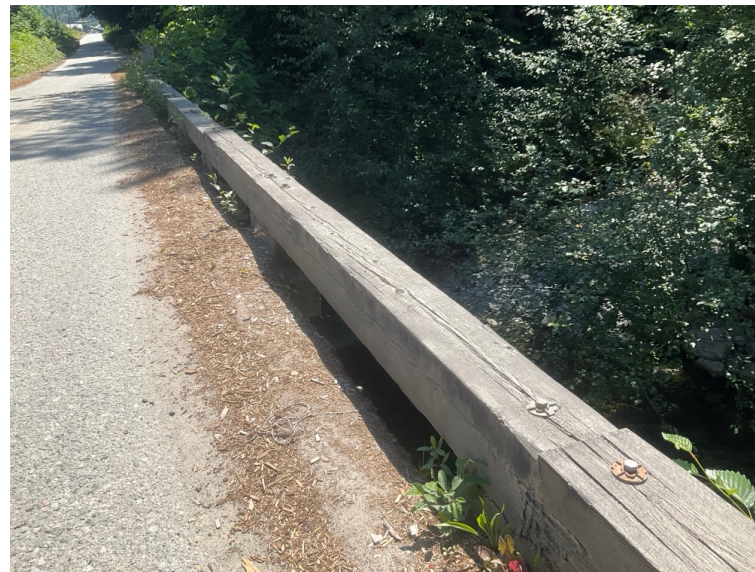
Guard Rail

Curb Rail/Blocks/Posts      **Poor**      Becoming loose, replace.

Ministry of Forests Reviewing Engineer: Richard Mills P.Eng.  
Review Date: Jan 26, 2026  
Recommended Load Rating: L150 or 136 tonnes  
Recommended Next Inspection: 2027  
Comments: Replace guardrails within 3 years.

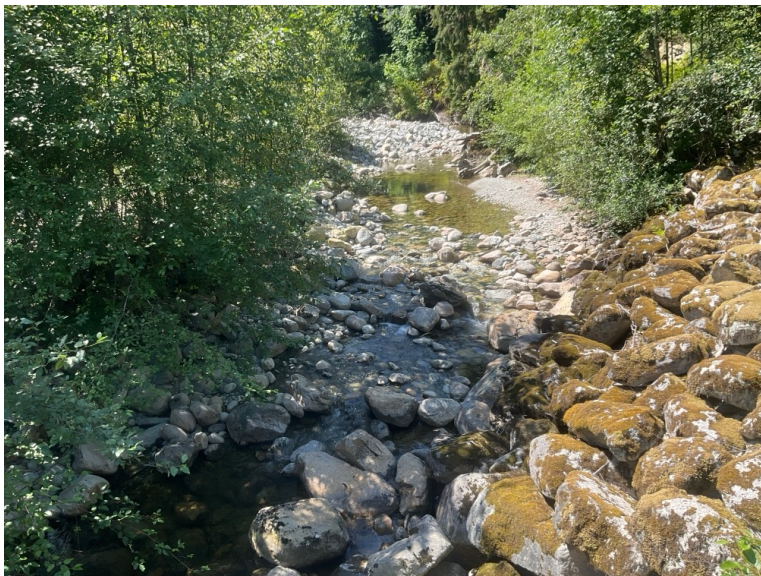
Upstream from Crossing

Constricted channel. High potential for high water.
