SC-8101  
SC-8101A

RAINY RIVER 0.71km

2025 Inspection

Crossing Name Dolly Creek

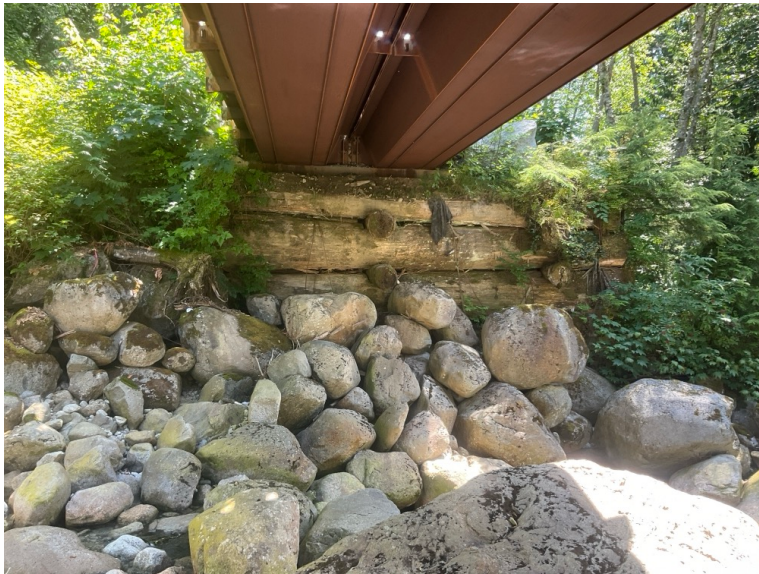
Left Bank Abutment when facing downstream

Sills located behind cribs. Monitor abutments due to age of crib.

| Item | Monitor Description | Frequency |
|---|---|---|
| 1 | Monitor abutments | Routine Inspection |
