SC-8110  
SC-8110

ROBERTS FLUME 0.69km

2025 Inspection

Crossing Name Lower Clack Creek

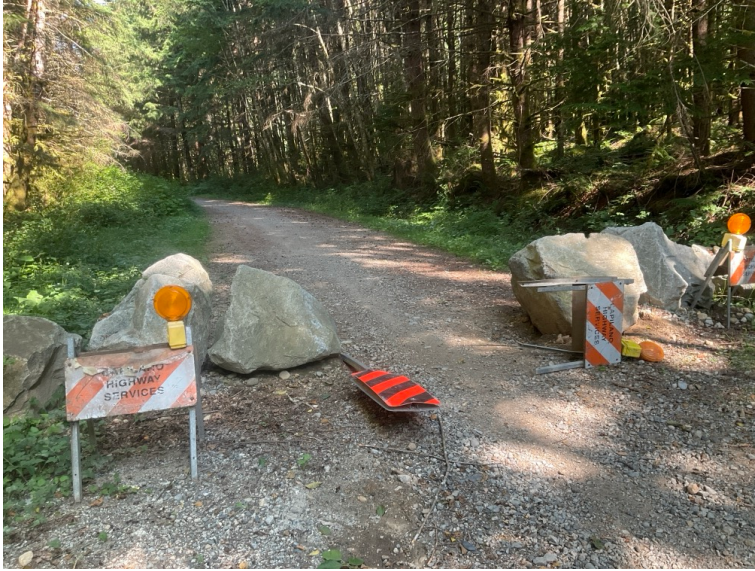
Approach from Right Bank when facing downstream
