SC-8143  
SC-8143

SECHELT DAKOTA 33.8km

2025 Inspection

Structure Class Major Culvert

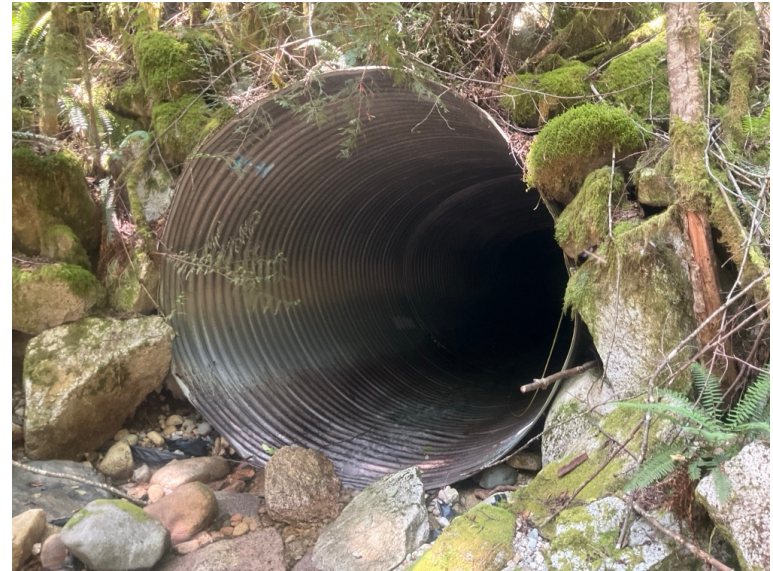
Inlet      Good

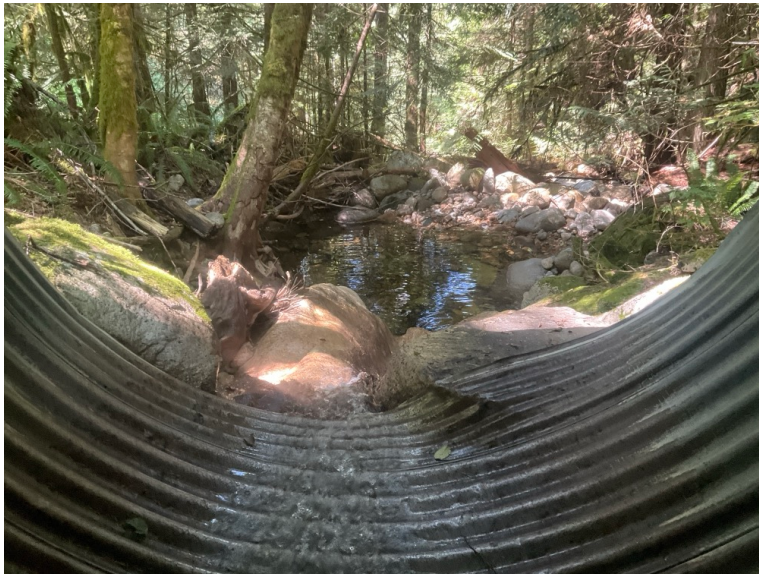
Outlet      Good
