SC-8152  
SC-8152

SECHELT DAKOTA 39.66km

2025 Inspection

Crossing Name Gray Creek

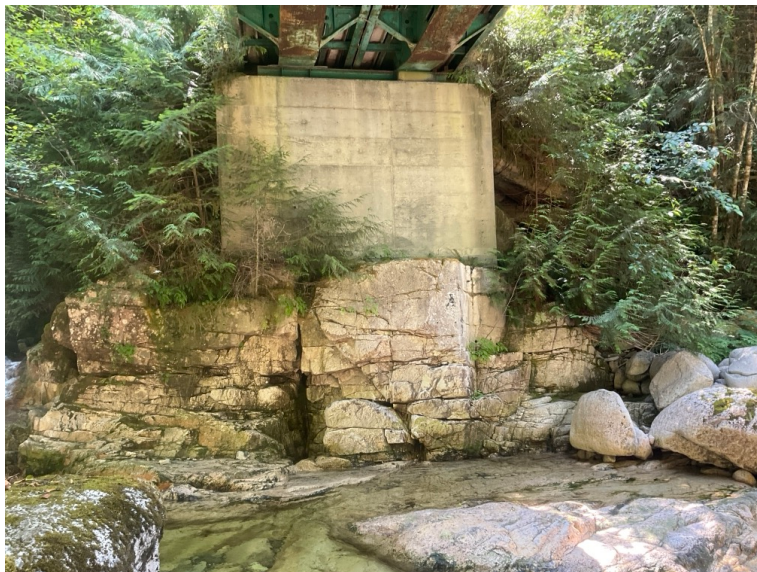
Left Bank Abutment when facing downstream

Cedar fill retaining crib both sides. 20 | 30 mm sap rot. No change since last inspection. Ds left wingwall - fill supported by 2 cedar logs. 20 - 30 mm sap rot. US left wingwall inaccessible. Appears ok from distance. Monitor.

| Item | Monitor Description | Frequency |
|---|---|---|
| 1 | Monitor cribs, ds wingalls | Routine Inspection |

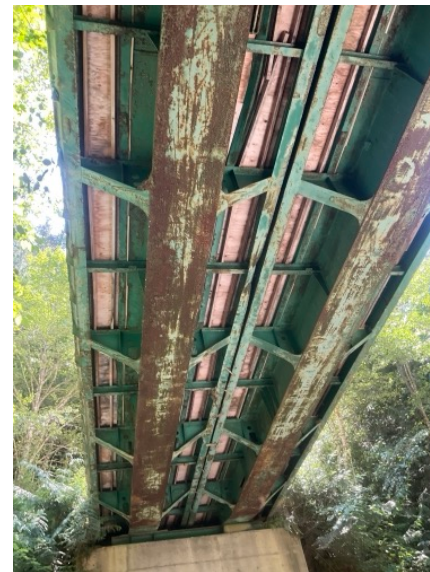
Superstructure

Girders Fair Old railcar. Surface corrosion.
