SC-8170  
SC-8170

## SECHELT CHAPMAN 2.2km

2025 Inspection

Crossing Name Gough Creek

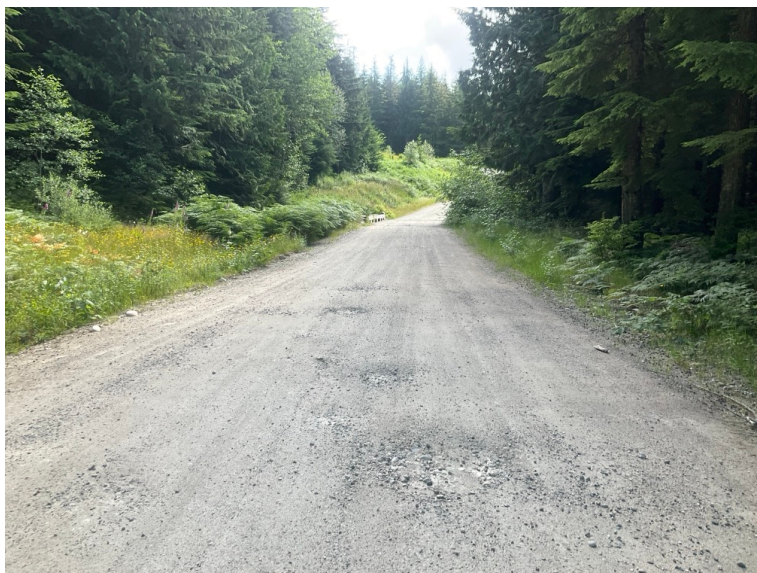
Approach from Right Bank when facing downstream

Fender Condition **Poor** **Missing**

| Repair Item | Repair Description |
|---|---|
| 1 Approach. Approach fenders (install). # of units.<br>Priority:High | Add approach barriers |

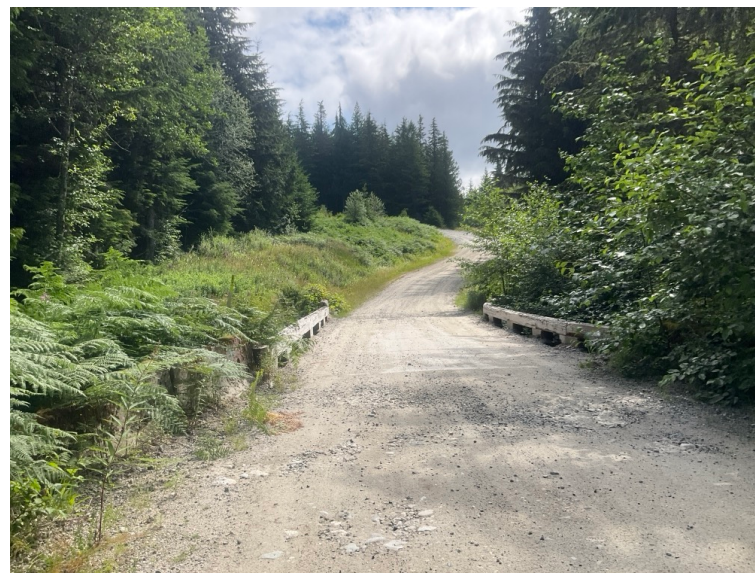
Deck

Curb Rail/Blocks/Posts      **Fair**      Replace in est 3 years

| Repair Item | Repair Description |
|---|---|
| 3 Structure. Full Curb Replacement. . Priority:Medium | Replace guardrails within 3 years |
