SC-8191  
SC-8191

TEXADA ISLAND 5.95km

2025 Inspection

Structure Class Major Culvert

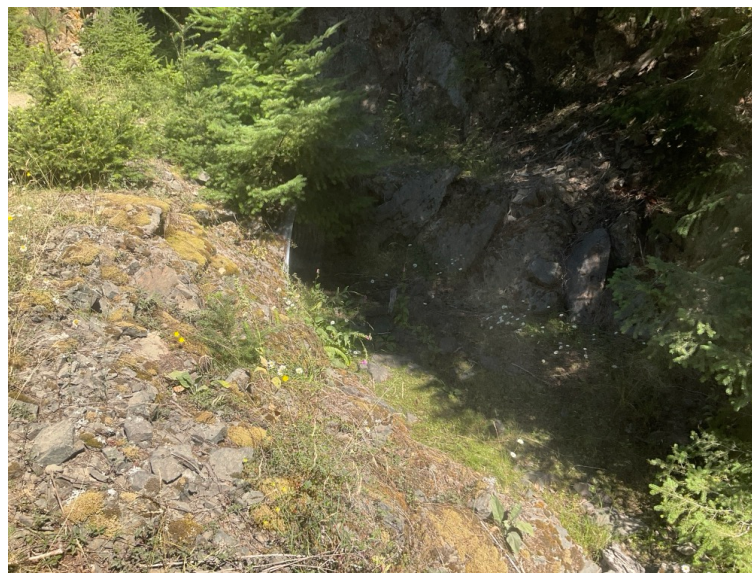
Inlet Good

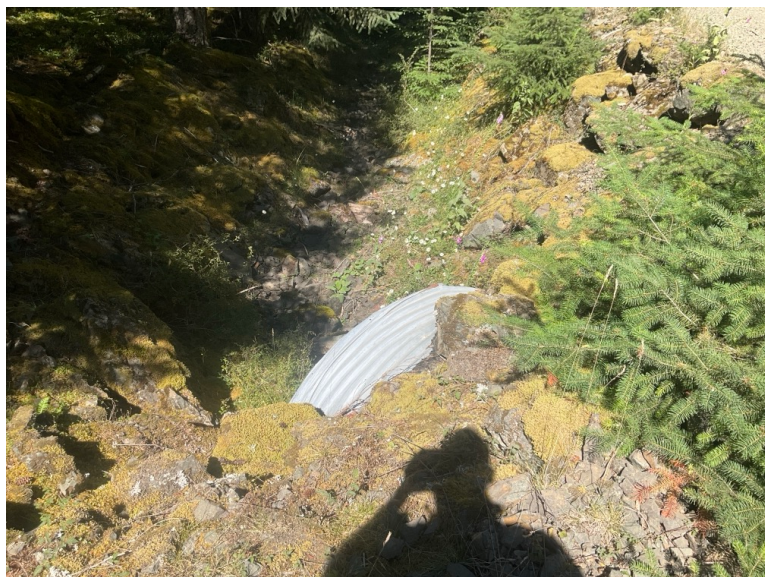
Outlet Good
