SC-8200  
SC-8200

THEODOSIA 0.1km

2025 Inspection

Ministry of Forests Reviewing Engineer: Richard Mills P.Eng.  
Review Date: Feb 5, 2026  
Load Rating: L150 or 136 tonnes  
Recommended Next Inspection: 2028  
Comments: Replace guardrails.

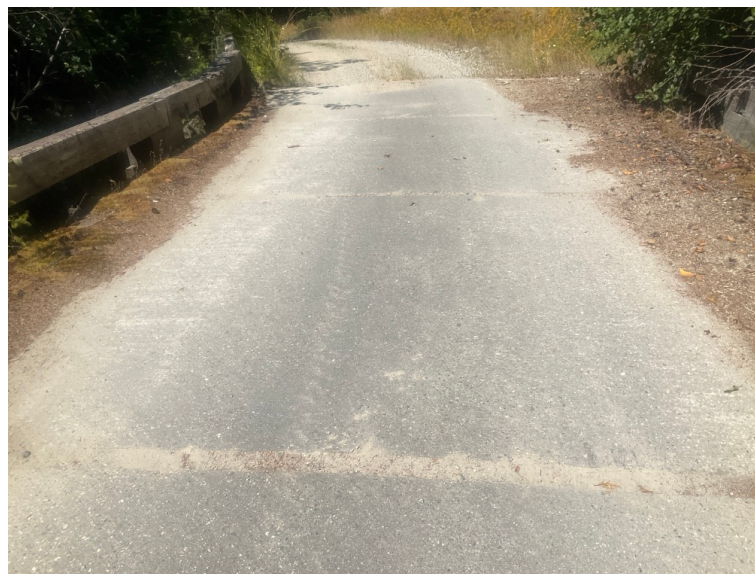
Curb Rail/Blocks/Posts      **Poor**      Rotting, replace

Overall Deck Condition      **Fair**

| Repair Item | Repair Description |
|---|---|
| 1 Structure. Full Curb Replacement. . Priority:High | Replace guardrails |
