SC-8201  
SC-8201

THEODOSIA 0.2km

2025 Inspection

Structure Class Permanent Bridge

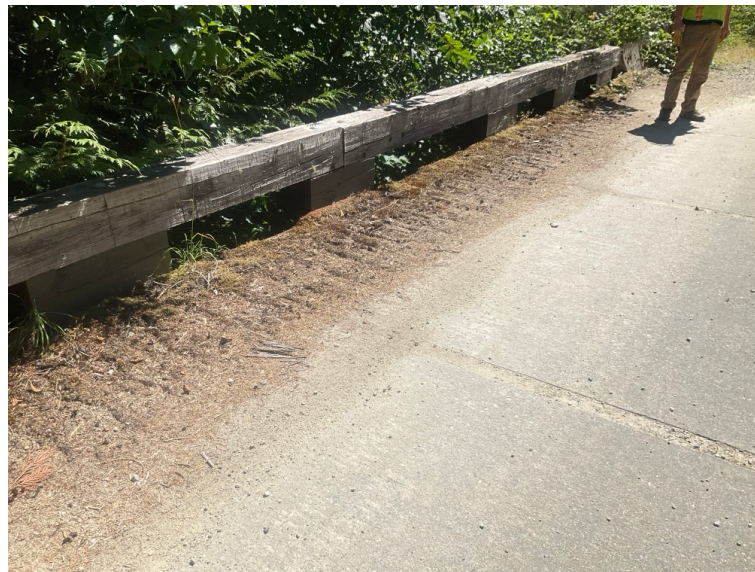
Deck

Curb Rail/Blocks/Posts      **Poor**      Guardrail rotten, replace.

| 1 | Structure. Curb Maintenance. Replace guardrails<br># sites. Priority:High |

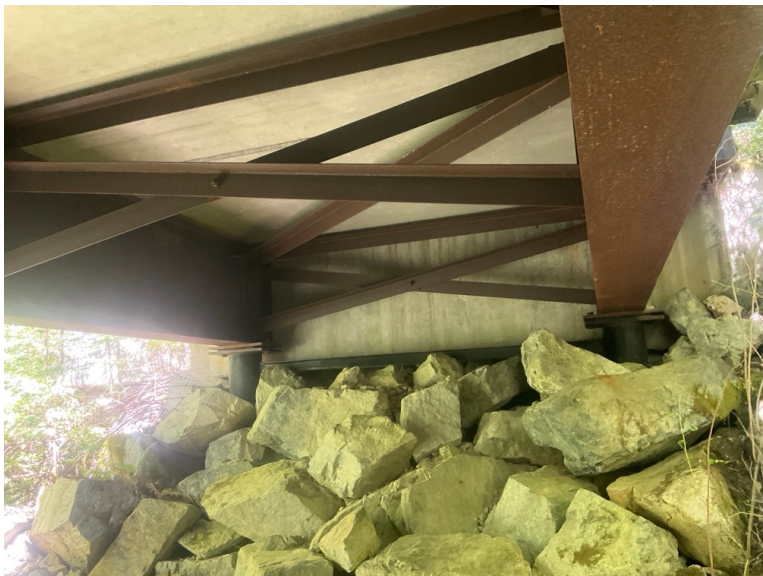
Right Bank Abutment when facing downstream

Riprap **Fair** **Minor scour**
