SC-8205  
SC-8205

THEODOSIA 2.5km

2025 Inspection

Date of Inspection 2025-07-30 1:31:35 PM

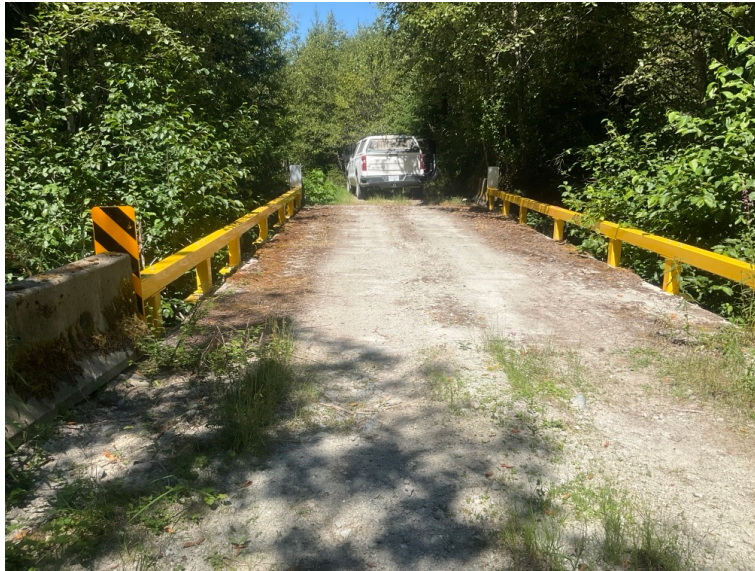
Approach from Left Bank when facing downstream

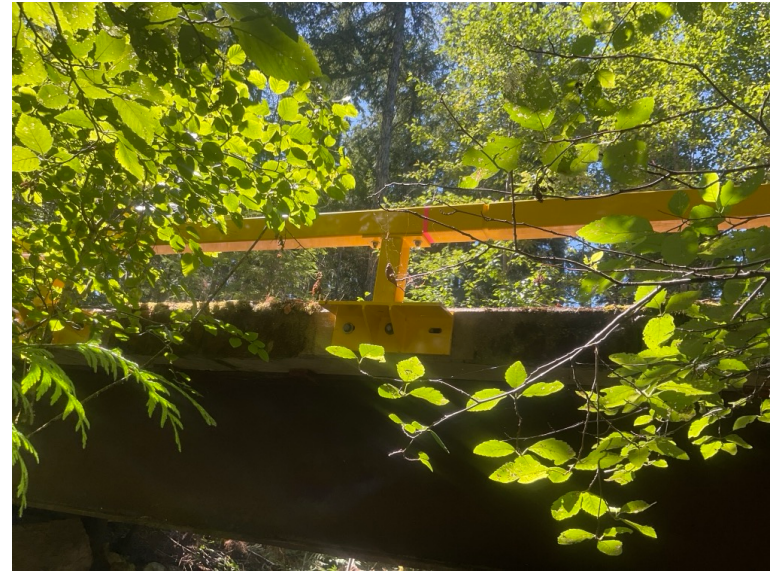
Only two bolts on middle 2 riser plates.

Hardware      **Fair**      1 bolt missing on ds and upstream side centre risers

Upstream Profile - upstream centre missing one bolt

Ministry of Forests Reviewing Engineer: Richard Mills P.Eng.  
Review Date: Feb 5, 2026  
Load Rating: L165 or 150 tonnes  
Recommended Next Inspection: 2028  
Comments: Attach missing bolts on risers.

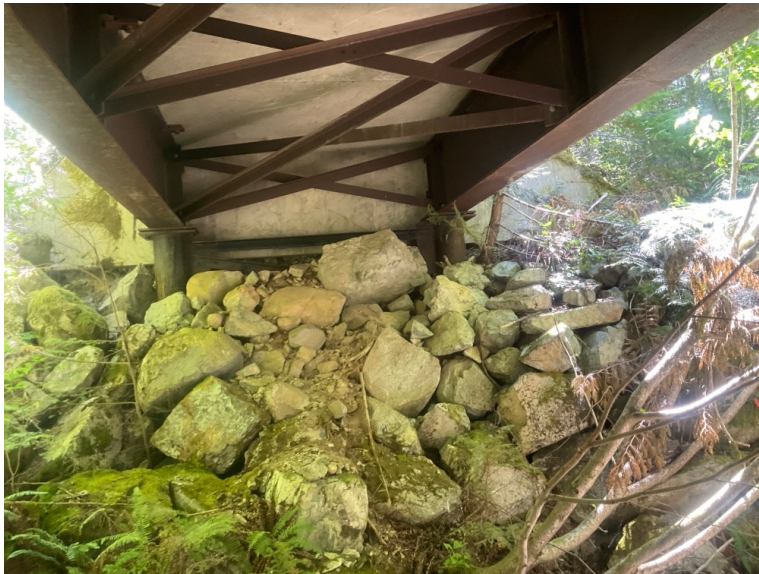
Left Bank Abutment when facing downstream

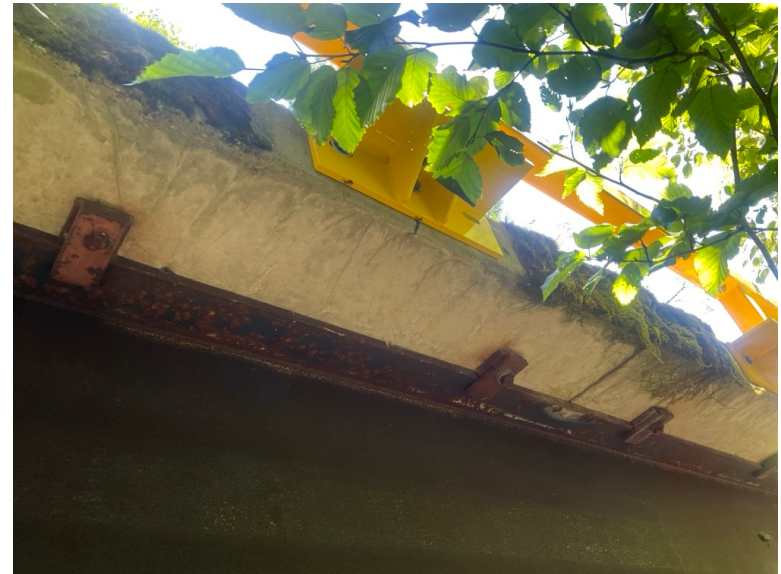
Downstream Profile - centre riser missing bolt
