SC-8208  
SC-8208-1

THEODOSIA 3.3km

2025 Inspection

Structure Class Major Culvert

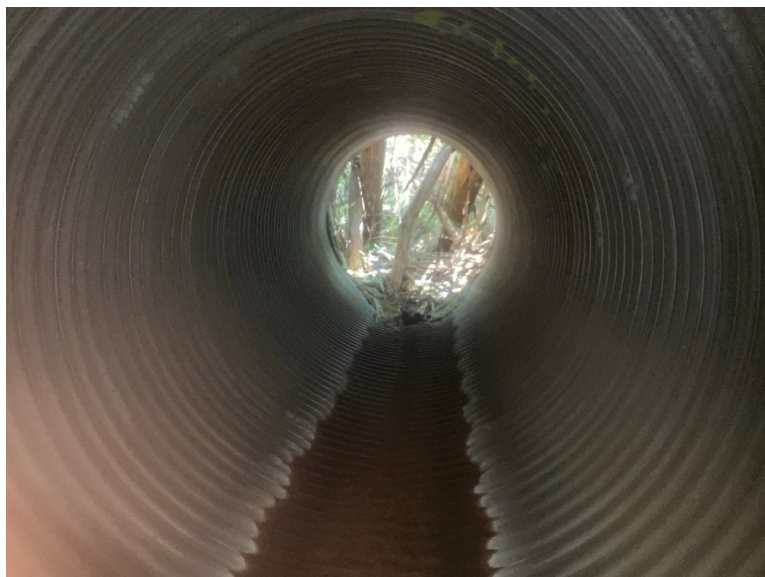
Inlet Fair

Trash Rack Fair Old logs

Consider removing or replacing log trash rack.
