SC-8220  
SC-8220

THEODOSIA 13.8km

2025 Inspection

Structure Class Major Culvert

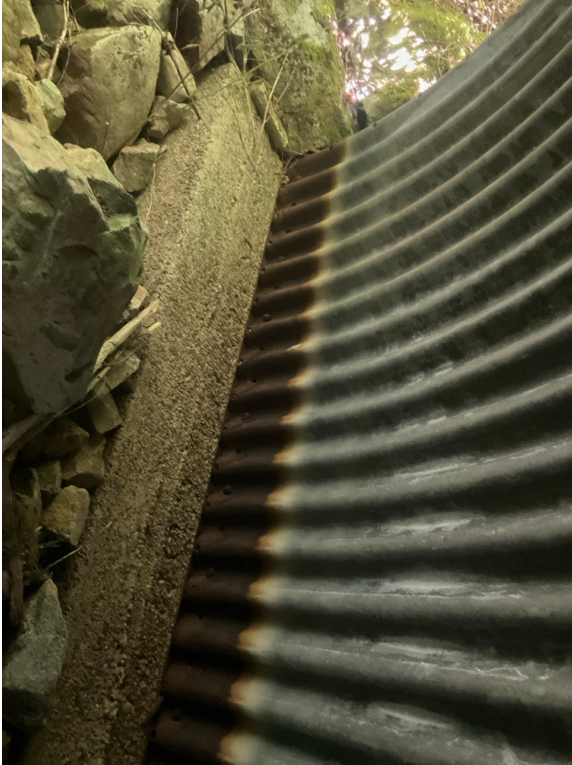
Culvert Floor

Floor      Good

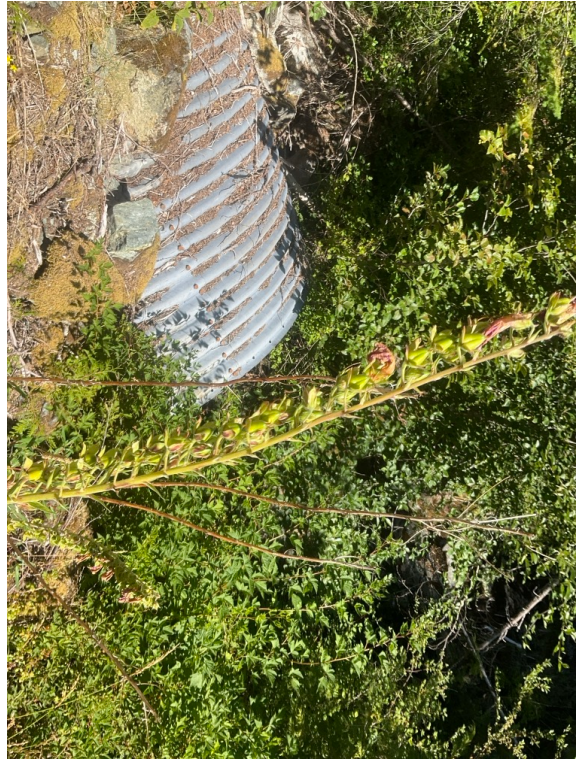
Inlet      Good

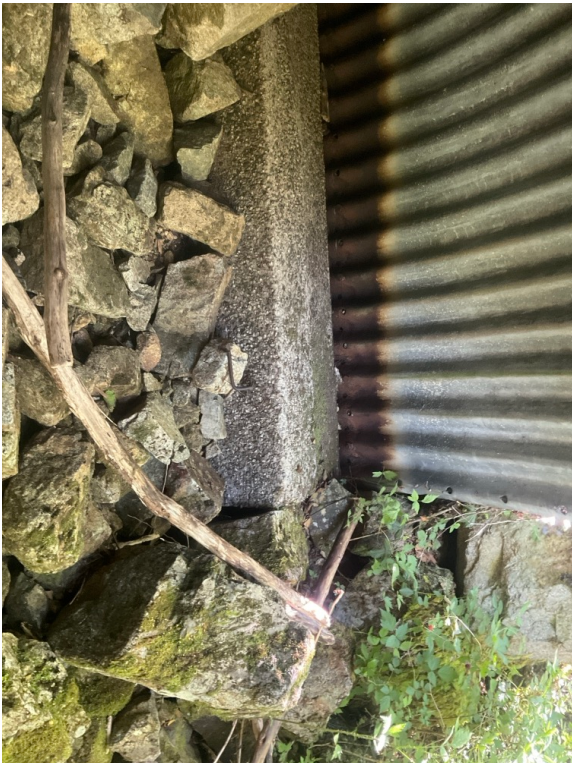
Outlet      Good
