SC-8225  
SC-8225

THEODOSIA 0.35km

2025 Inspection

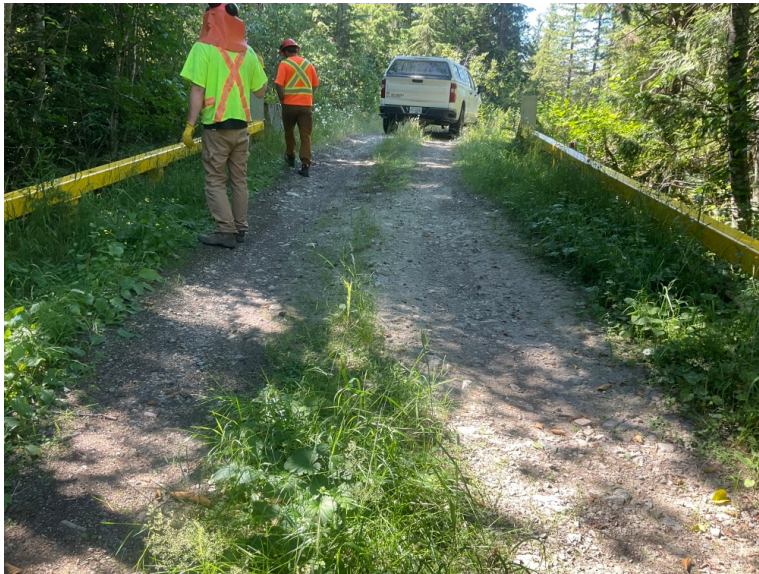
Deck

Large puddle on deck

Running Surface      Fair      Large puddle on deck

Ministry of Forests Reviewing Engineer: Richard Mills P.Eng.  
Review Date: Feb 6, 2026  
Load Rating: L165 or 150 tonnes  
Recommended Next Inspection: 2028  
Comments: Fill potholes on deck.

| Repair Item | Repair Description |
|---|---|
| 1 Structure. Add Fill Cover. # of items. Priority:Low | Fill deck pothole (puddle) |
