SC-8226  
SC-8226

THEODOSIA 0.65km

2025 Inspection

Ministry of Forests Reviewing Engineer: Richard Mills P.Eng.  
Review Date: Feb 6, 2026  
Load Rating: L165 or 150 tonnes  
Recommended Next Inspection: 2028

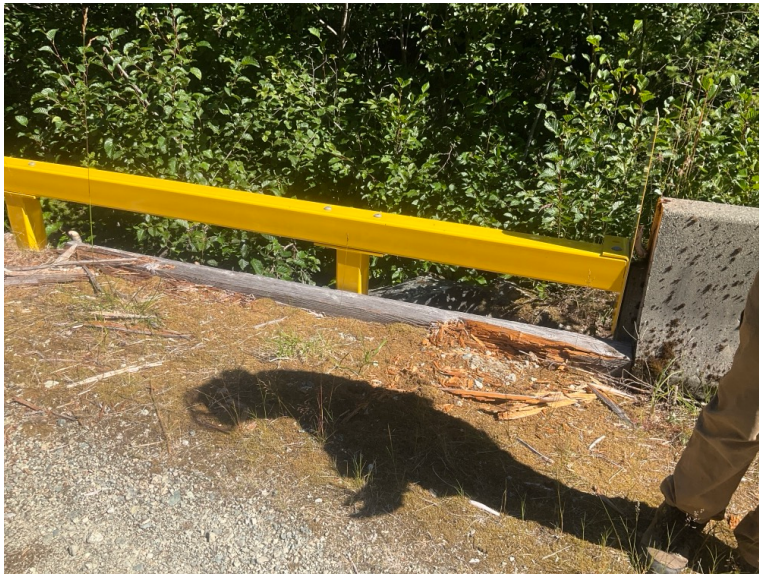
Deck Joints      **Fair**      Ok from bottom

Gravel Surface      **Fair**

| Item | Monitor Description | Frequency |
|---|---|---|
| 1 | Monitor gravel retention strips. May need to replace | Routine Inspection |

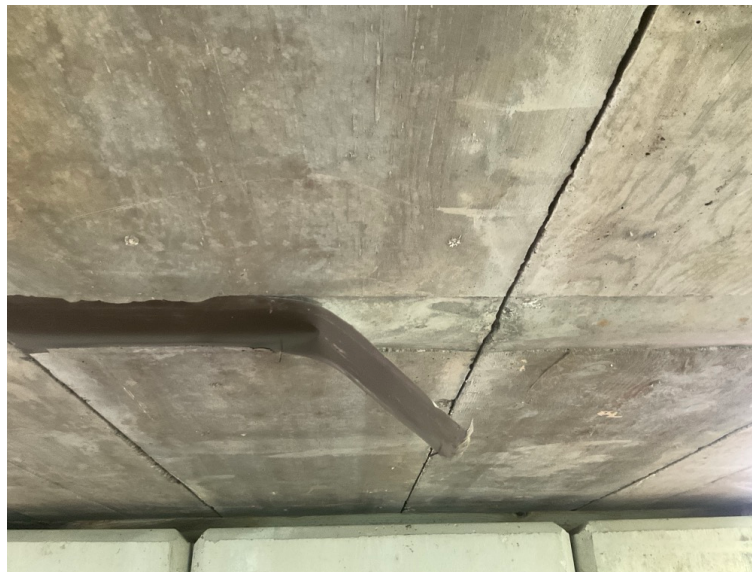
Superstructure

Girders Fair Poorly finished, but appears ok structurally
