SC-8229  
SC-8229

## THEODOSIA 1.3km

2025 Inspection

Superstructure Concrete Slab Girders

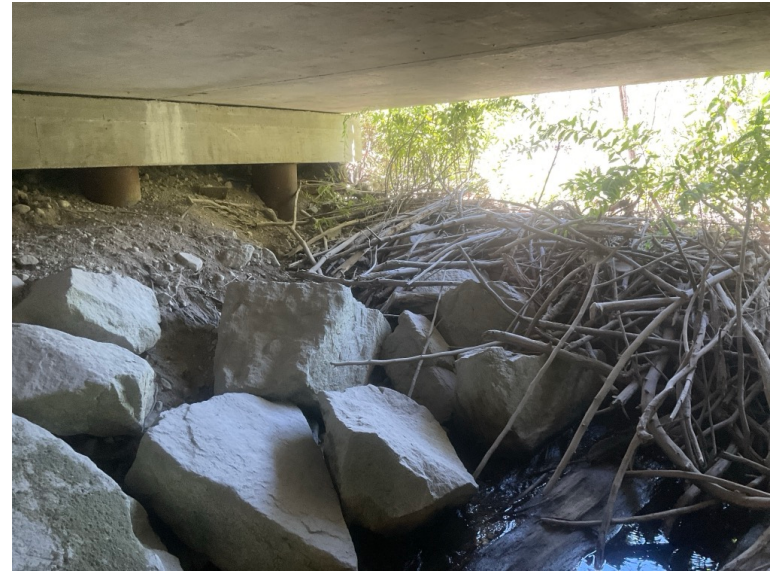
Right Bank Abutment when facing downstream

Piles or Posts **Fair** Surface corrosion. Monitor

| Item | Monitor Description | Frequency |
|---|---|---|
| 1 | Monitor posts - corrosion | Routine Inspection |
