SC-8237  
SC-8237

THEODOSIA 11.9km

2025 Inspection

Crossing Name Appleton Creek

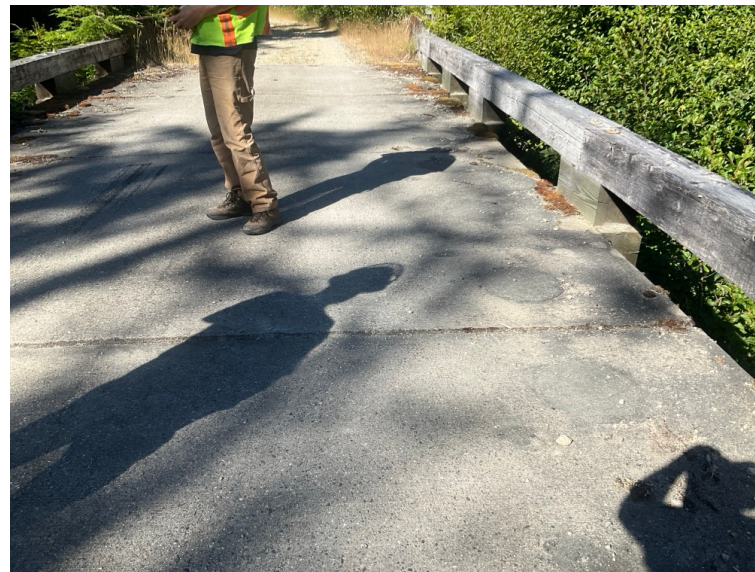
Deck

Curb Rail/Blocks/Posts      Poor      Loose, rotting. Replace.

| Repair Item | Repair Description |
|---|---|
| 1 Structure. Full Curb Replacement. . Priority:High | Replace guardrailss |

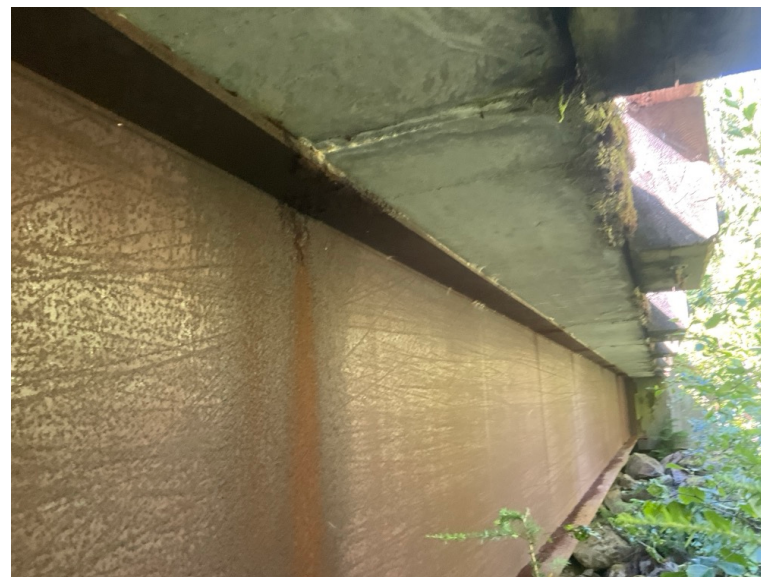
Upstream Profile

Girders Fair Corrosion at deck joints. Monitor n

| 2 | Monitor girder corrosion | Routine Inspection |

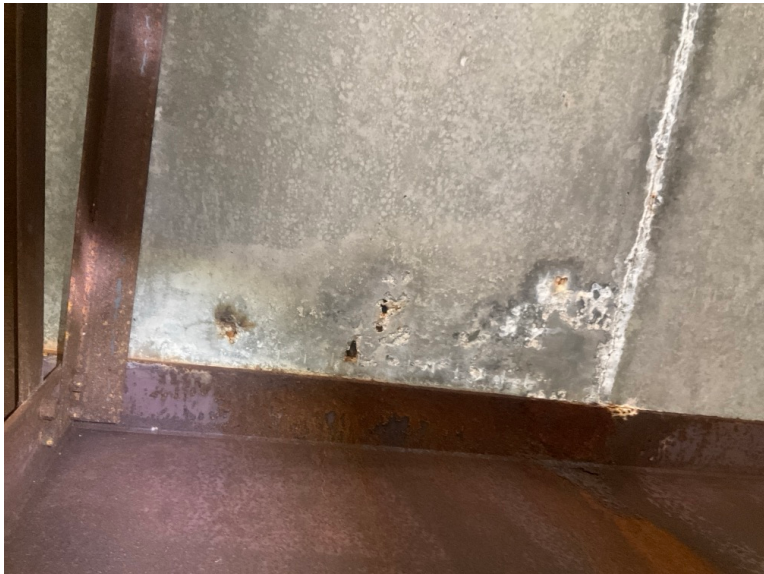
Deck Joints      Fair      Not flush with deck.
