SC-8242  
SC-8242

THEODOSIA 11.52km

2025 Inspection

Crossing Name Junction Creek

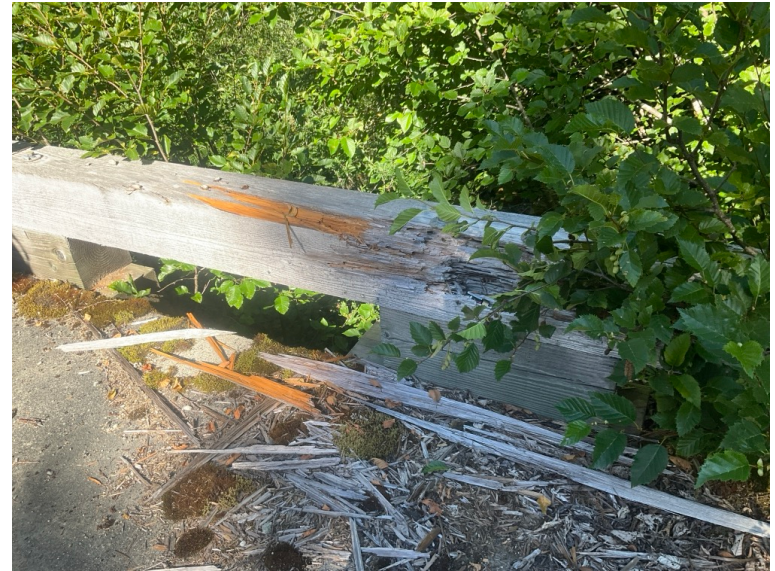
Guard Rail

Curb Rail/Blocks/Posts      **Poor**      Replace guardrails

Ministry of Forests Reviewing Engineer: Richard Mills P.Eng.  
Review Date: Feb 6, 2026  
Load Rating: L165 or 150 tonnes  
Recommended Next Inspection: 2028  
Comments: Replace guardrails.

| Repair Item | Repair Description |
|---|---|
| 1 Structure. Full Curb Replacement. . Priority:High | Replace guardrails |

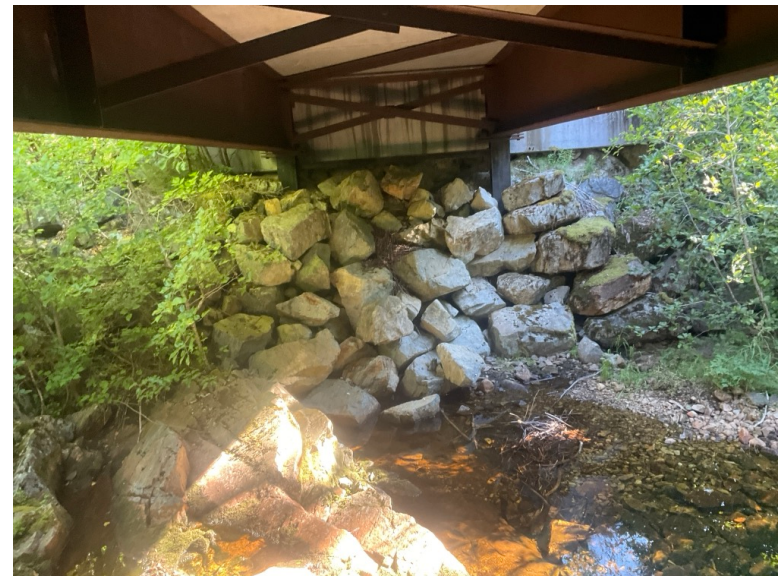
Left Bank Abutment when facing downstream

Riprap Good Steep on left side
