SC-8250  
SC-8250

## ROBERTS FLUME 2.4km

2025 Inspection

Crossing Name Upper Clack Creek

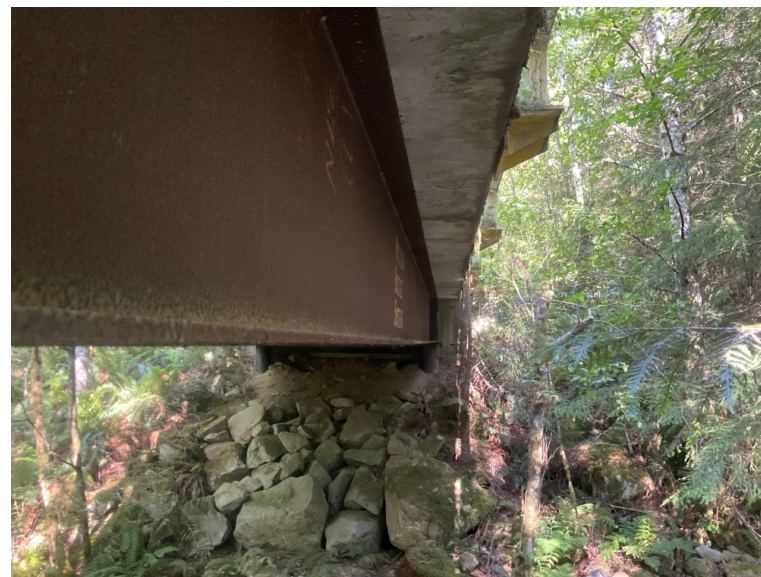
Upstream Profile

Slight girder deflection noted. Approx 10mm at centre, both sides equal. Monitor.

Girders Good      Slight deflection noted (10mm, both girders)

| Item | Monitor Description | Frequency |
|---|---|---|
| 1 | Monitor girders | Routine Inspection |
