SC-8309  
SC-8309

LOIS FSR 8133 BR01 19.33km

2025 Inspection

Crossing Name My Creek

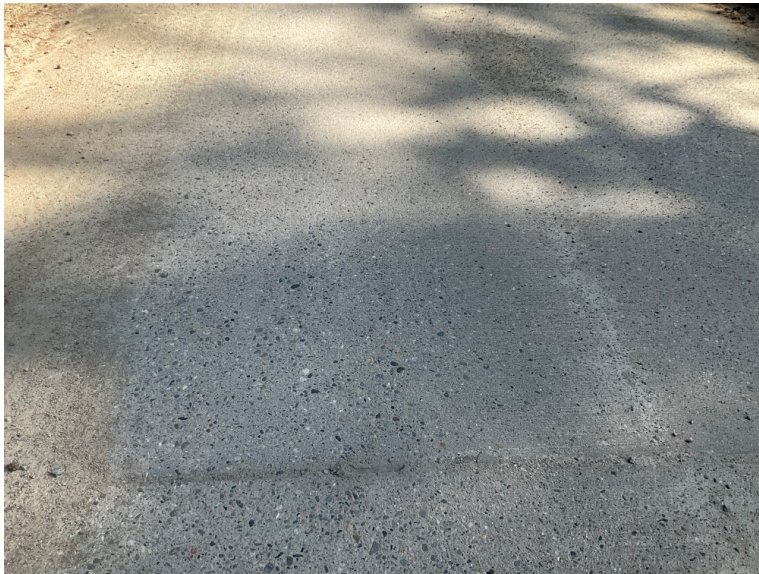
Deck Joints      **Fair**      Some joints are not flush with deck, grout 10mm below surface. Appear ok from below.  
Monitor

| Item | Monitor Description | Frequency |
|---|---|---|
| 1 | Monitor deck joints | Routine Inspection |

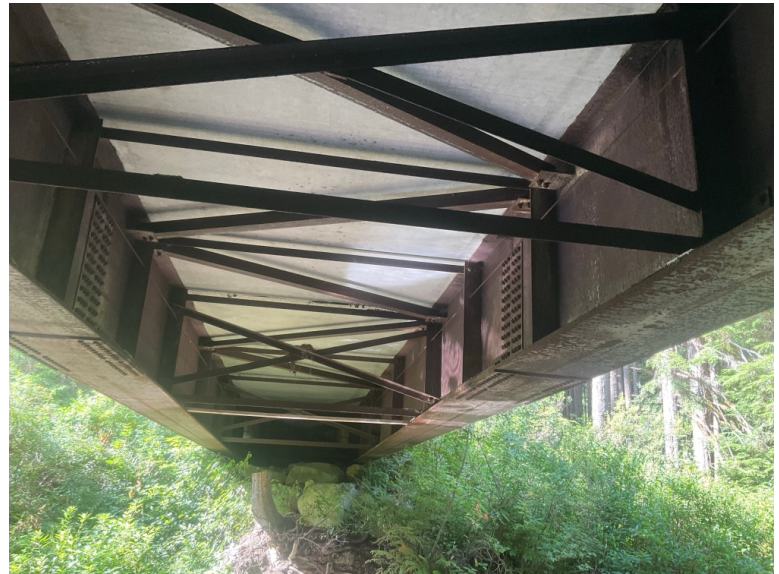
Superstructure

Girders Fair

Rust scale starting. Monitor.

| 2 | Monitor corrosion | Routine Inspection |
