SC-8311  
SC-8311

LOIS FSR 8133 BR01 17.54km

2025 Inspection

Road Name LOIS FSR 8133 BR01

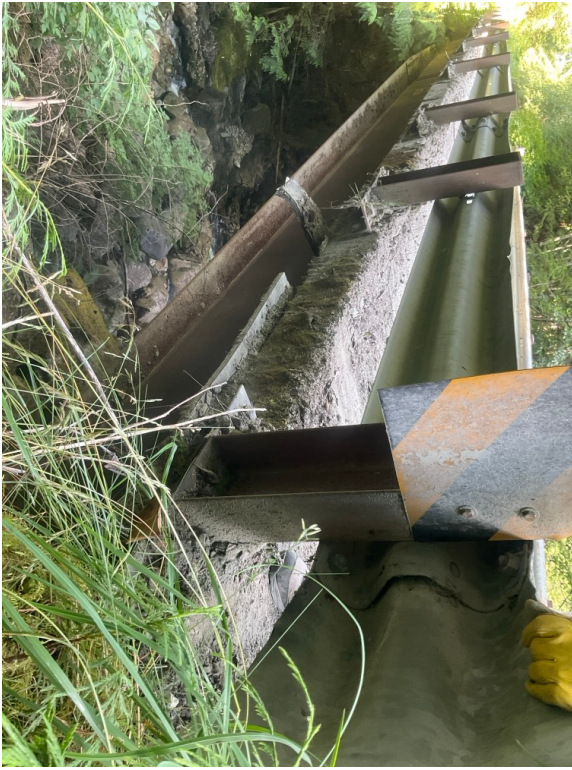
Guard Rail

Two upstream right guardrail risers are loose. Tighten or replace.

Curb Rail/Blocks/Posts      Fair      2 loose posts upstream right side

| Repair Item | Repair Description |
|---|---|
| 2 Structure. Curb Maintenance. # sites. Priority:Medium | Tighted guardrail risers |
