SC-8317  
SC-8317

## TEXADA ISLAND 2.25km

2025 Inspection

Structure Class Major Culvert

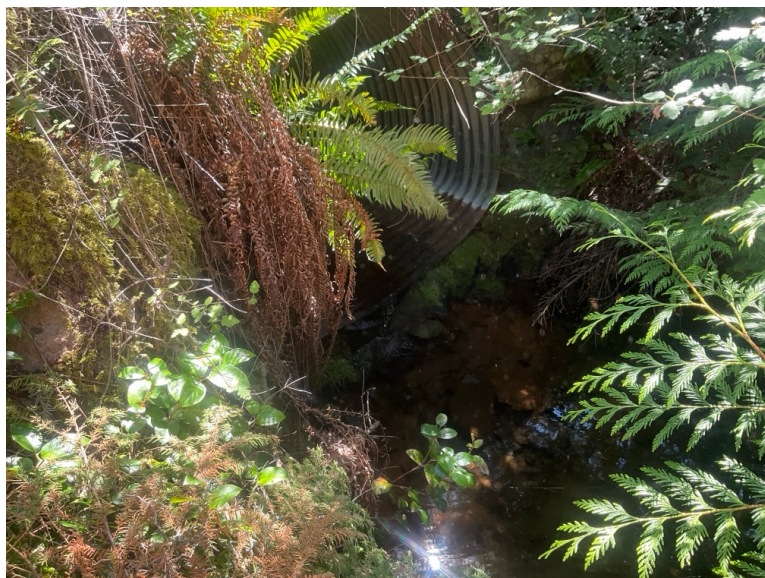
Outlet Good

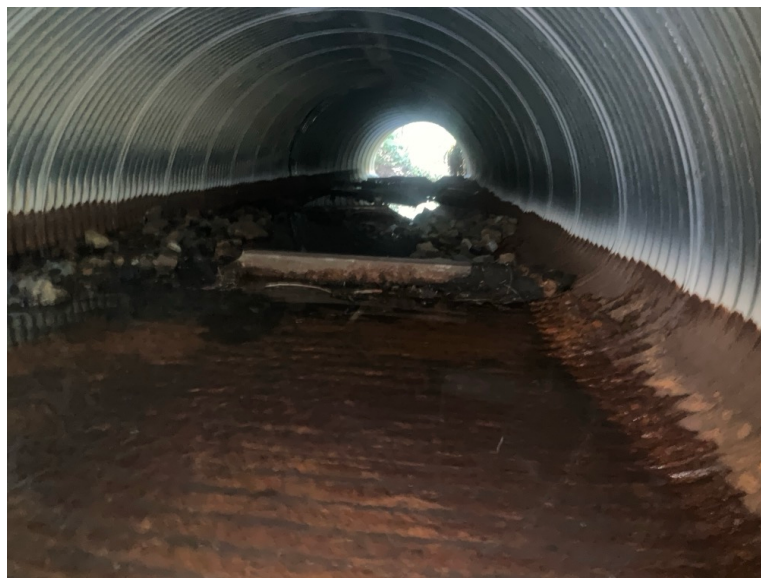
Inlet Good
