SC-8318  
SC-8318

TEXADA ISLAND 0.02km

2025 Inspection

Structure Class Major Culvert

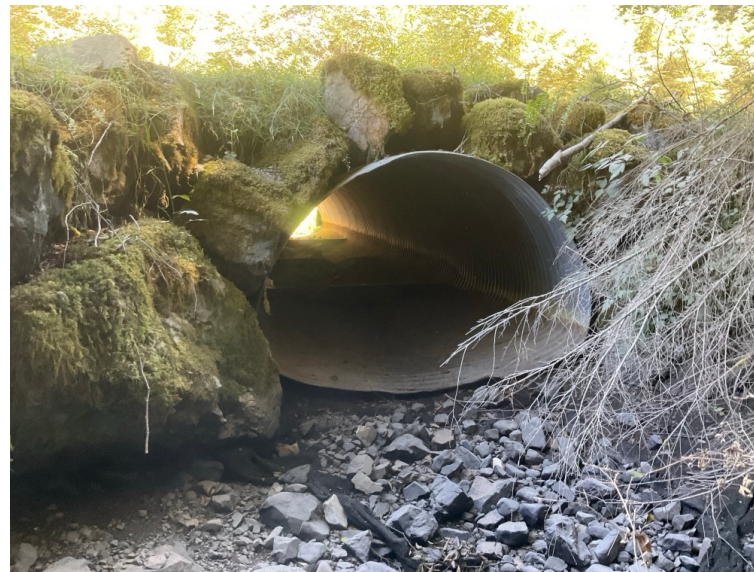
Outlet Good

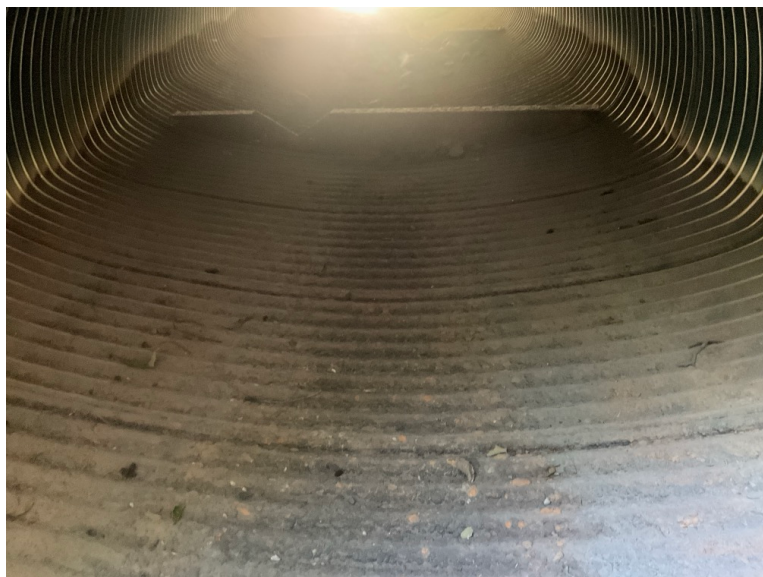
Culvert Floor

Floor Fair Minor corrosion

1 Monitor corrosion, scour

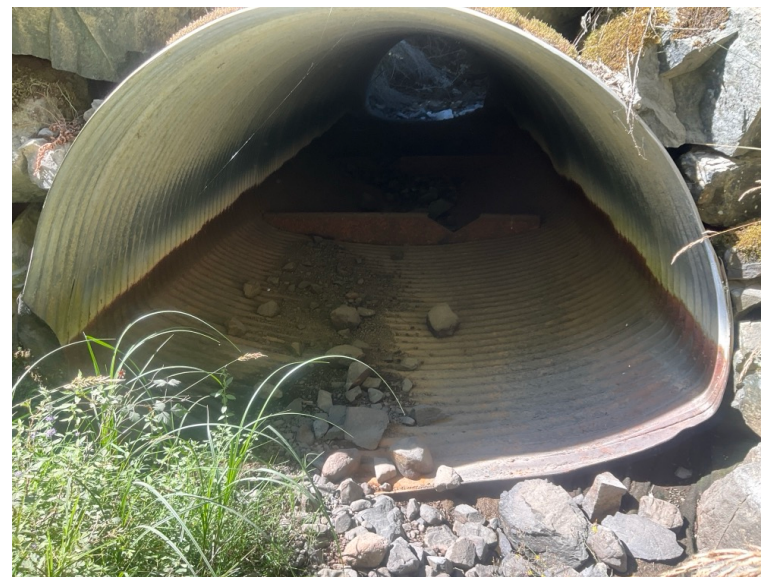
Inlet Good
