SC-8320  
SC-8320

TEXADA ISLAND 0.5km

2025 Inspection

Structure Class Major Culvert

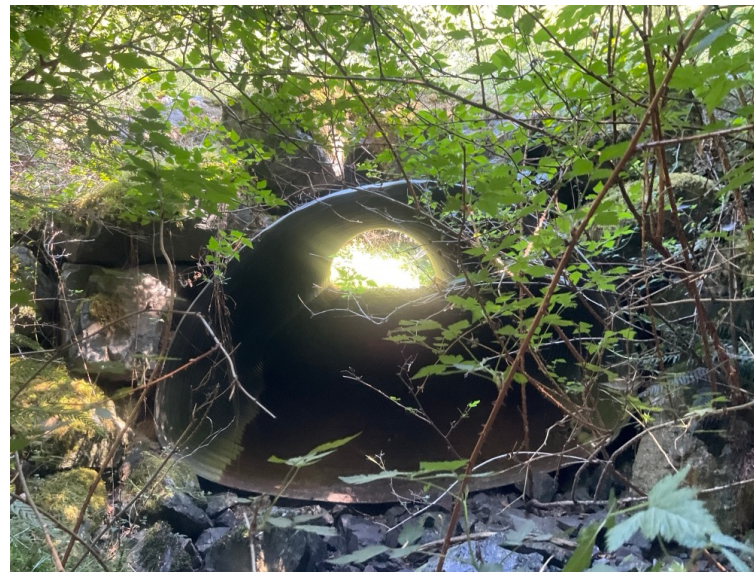
Outlet Good

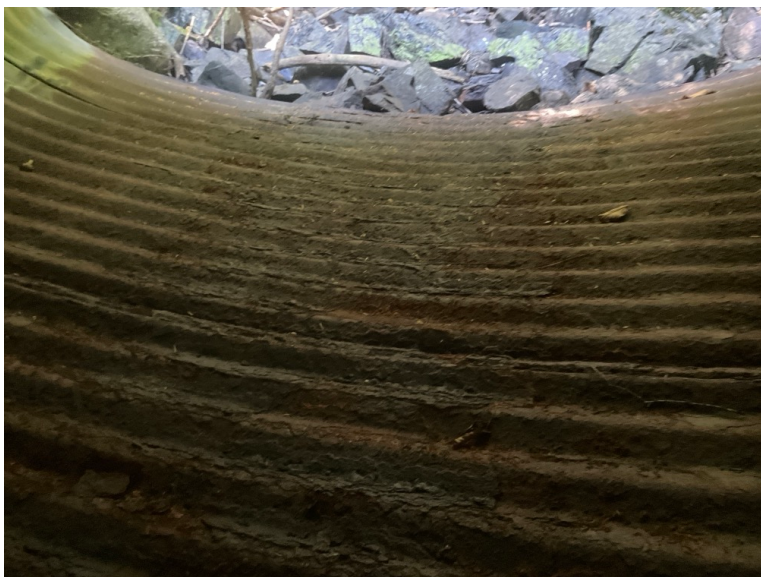
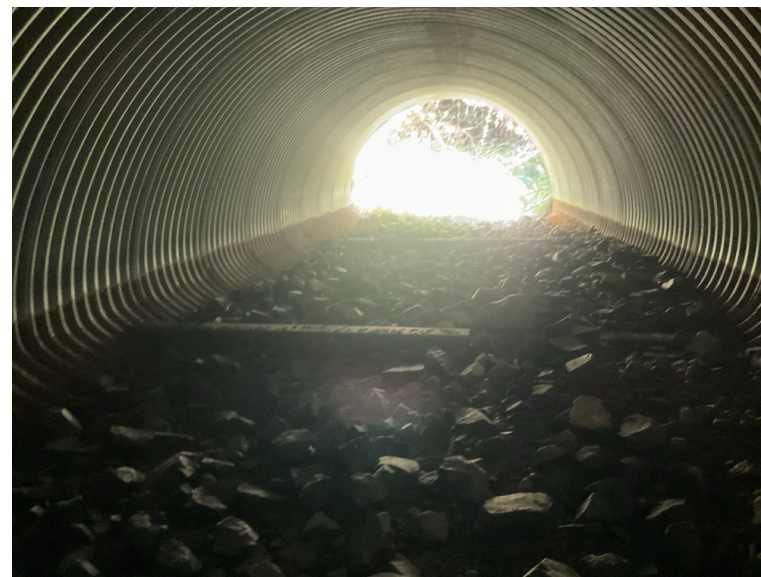
Culvert Floor

Floor Fair Moderate Corrosion

| Item | Monitor Description | Frequency |
|---|---|---|
| 1 | Monitor floor corrosion | Routine Inspection |

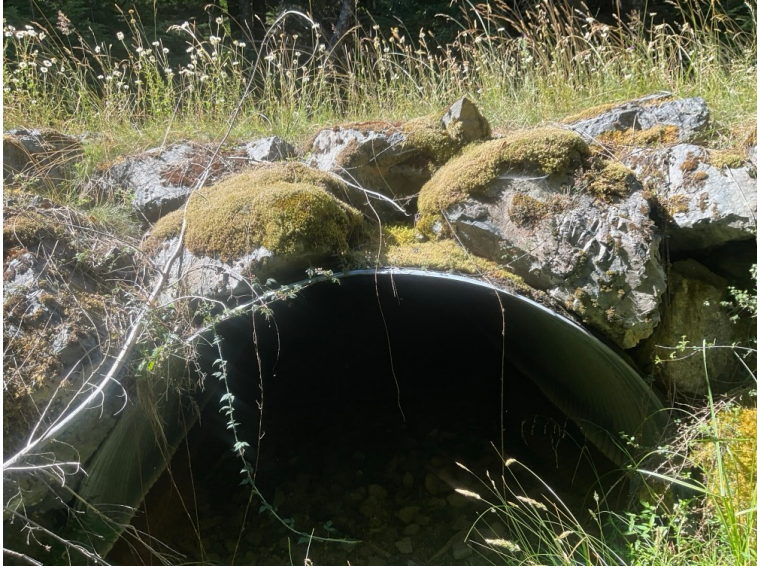
Inlet Good
