SC-8321  
SC-8321

TEXADA ISLAND 4.75km

2025 Inspection

Structure Class Major Culvert

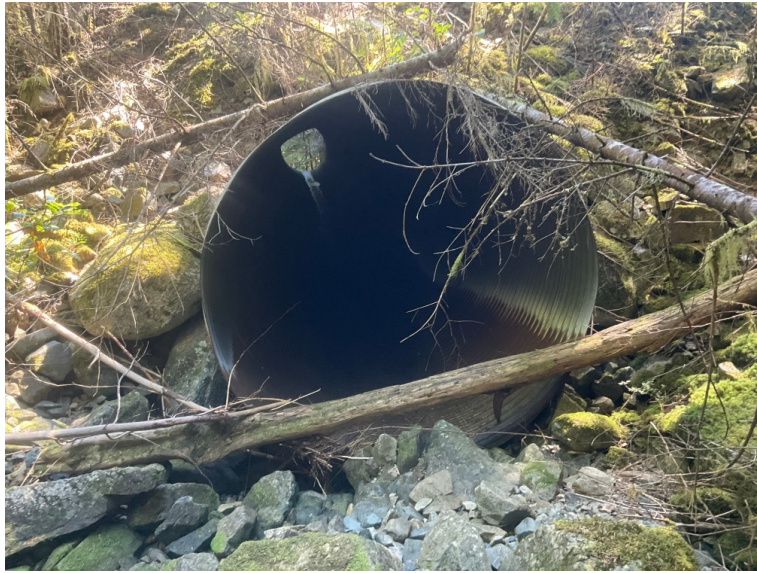
Inlet Good

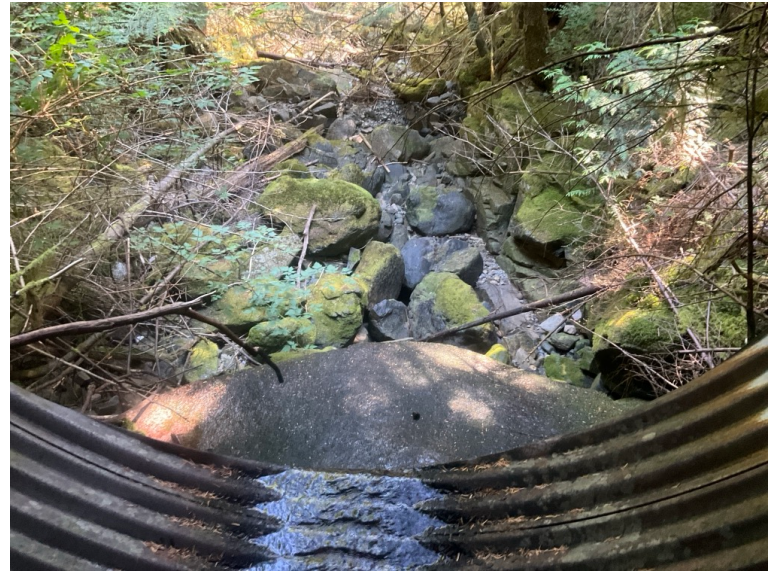
Outlet Fair Minor scour

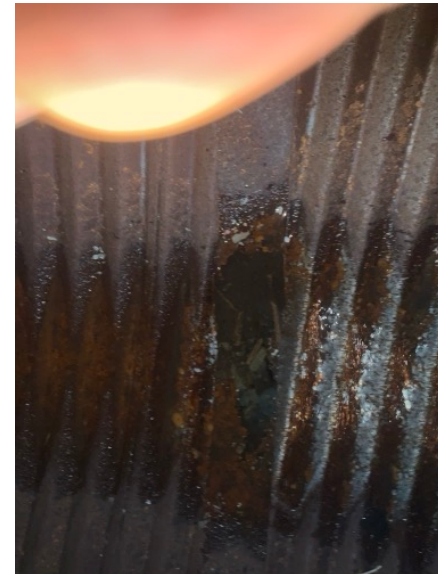
Joint - 1st from us side

No apparent change since last inspection. First 2 joints have holes at bottom, on floor. Joint 1 has hole approx 15cm x 30cm, 2nd joint has small 10cm x 10cm holes. Material under pipe in place, with no visible voids or signs of deformation. Rest of culvert floor and joints is solid. Outlet appears unchanged, no scour noted under pipe.

Coupled Connections Fair Holes at bottom

Continue to monitor for scour or increased floor corrosion.

| Item | Monitor Description | Frequency |
|---|---|---|
| 1 | Monitor scour, floor / joint corrosion | Routine Inspection |
