SC-8322  
SC-8322

## TEXADA ISLAND 4.8km

2025 Inspection

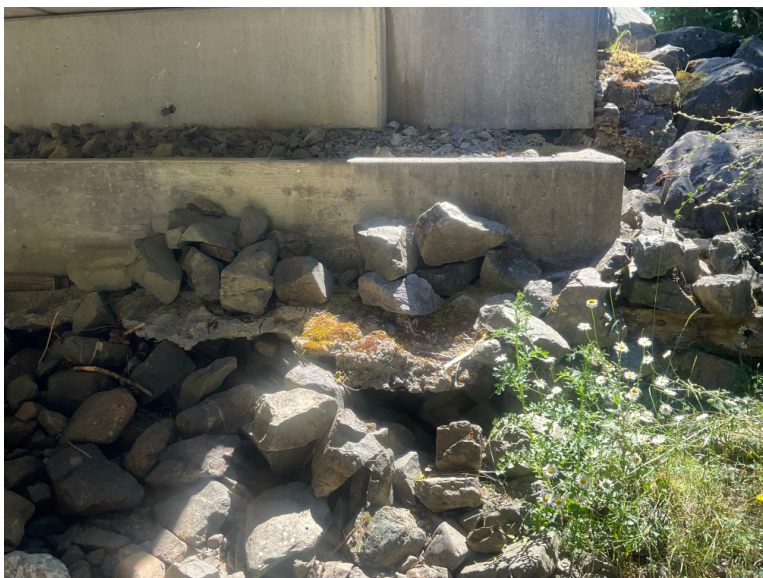
Left Bank Abutment when facing downstream

Riprap **Fair** Scoured left. Monitor.

| Item | Monitor Description | Frequency |
|---|---|---|
| 1 | Monitor scour left side | Routine Inspection |
