SC-8340  
SC-8340A

## HALFMOON CARLSON 3km

2025 Inspection

Crossing Name Wakefield Creek

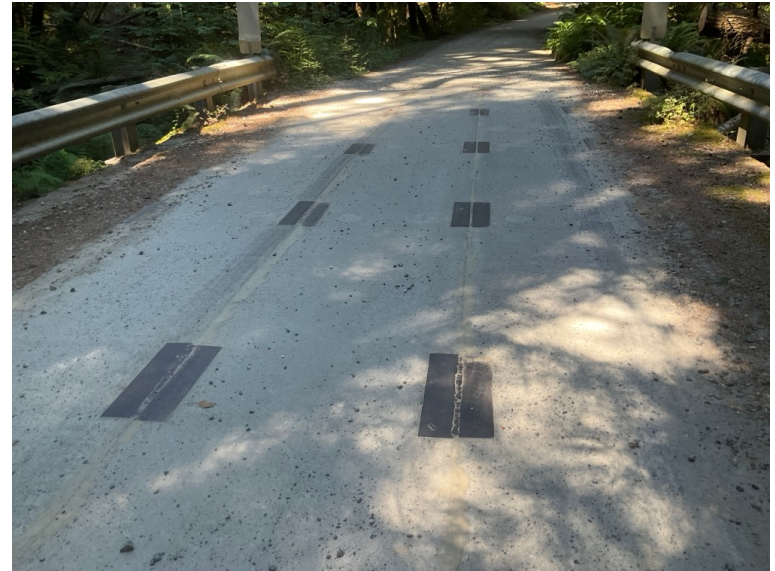
Overall Deck Condition      Good

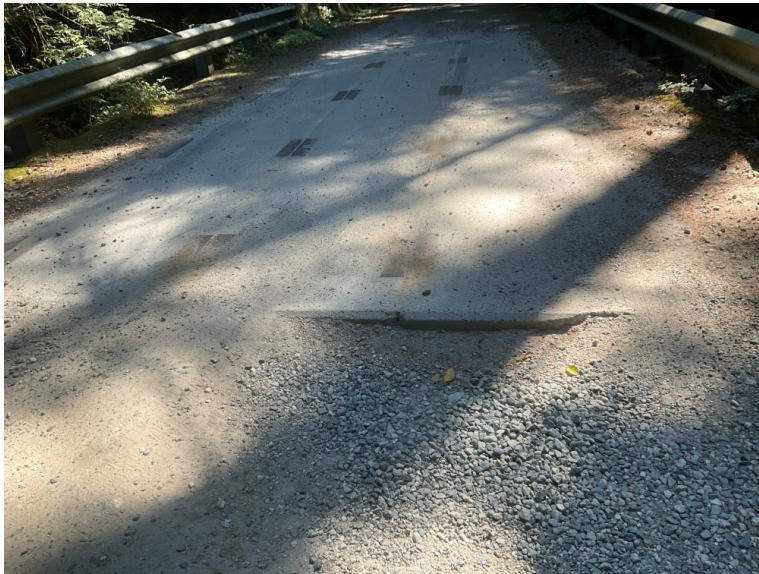
Pothole left approach

Approach from Left Bank when facing downstream - pothole

Ministry of Forests Reviewing Engineer: Richard Mills P.Eng.  
Review Date: Jan 26, 2026  
Recommended Load Rating: L150 or 136 tonnes  
Recommended Next Inspection: 2028  
Comments: Fill pothole at approach.

1 Approach. Approach fill  
repair. m³. Priority:Low

Fill pothole
