SC-8610  
SC-8610A

DUCK LAKE 0.15km

2025 Inspection

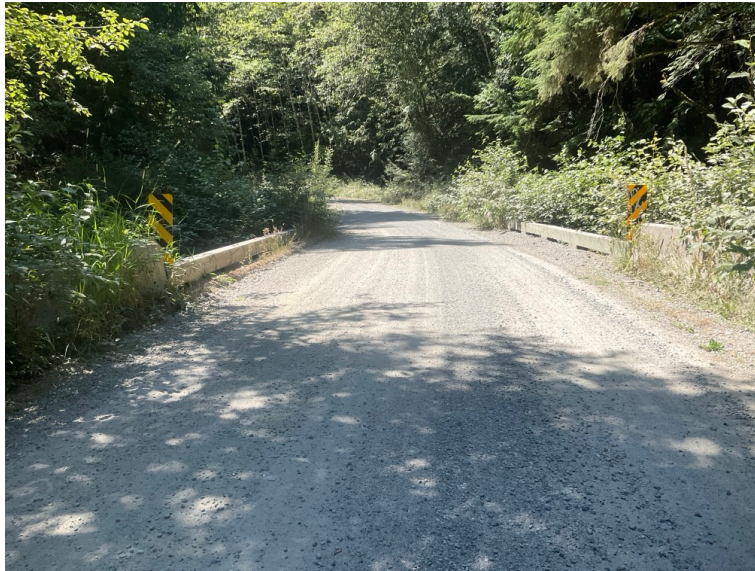
Approach from Left Bank when facing downstream

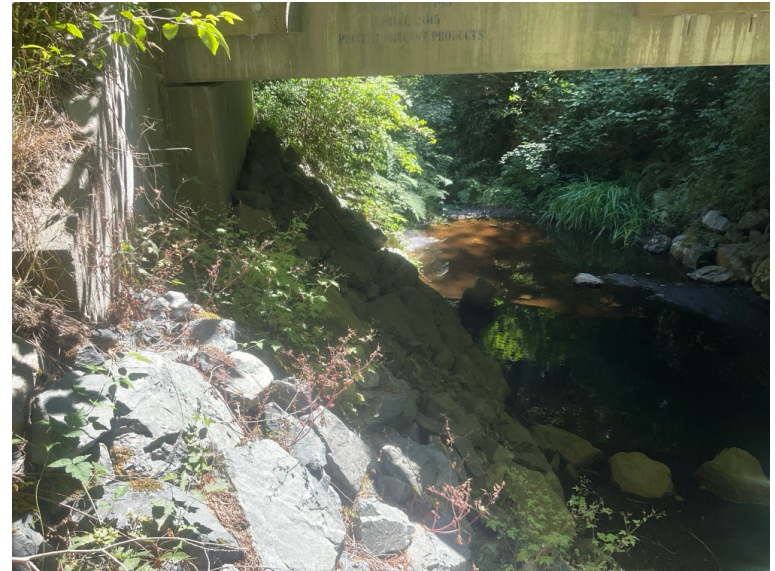
Left Bank Abutment when facing downstream

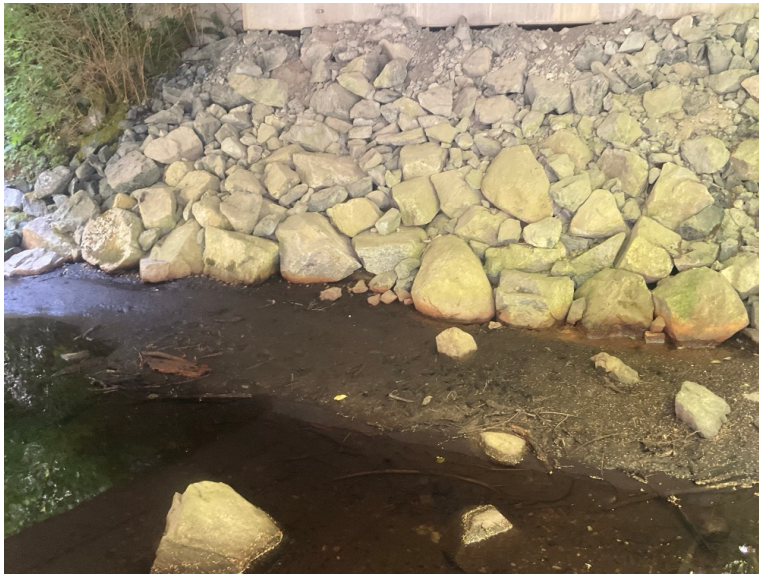
Right Bank Abutment when facing downstream

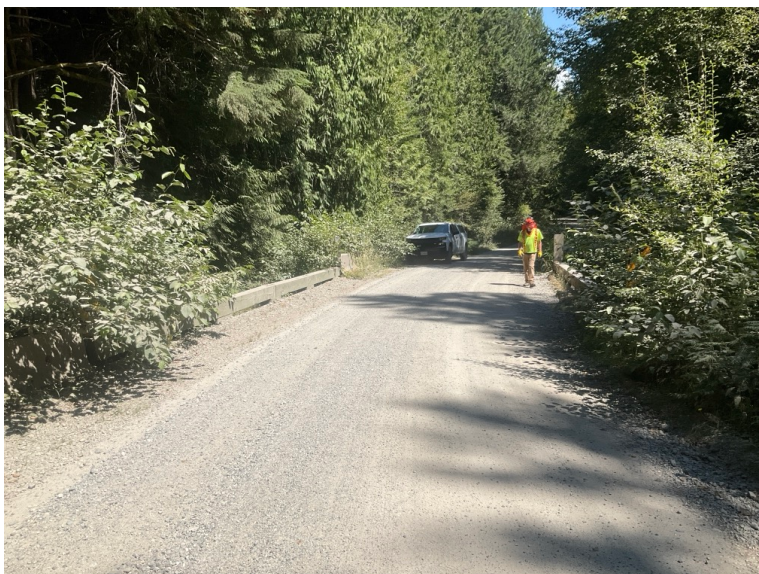
Approach from Left Bank when facing downstream
