SC-8615  
SC-8615

## SALTERY BAY 0.95km

2025 Inspection

Recommended Load Rating: L165 or 150 tonnes

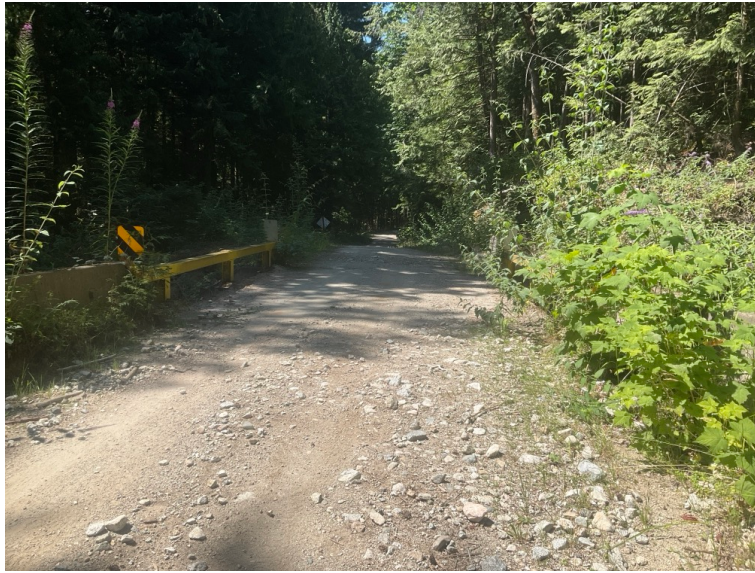
Approach from Left Bank when facing downstream

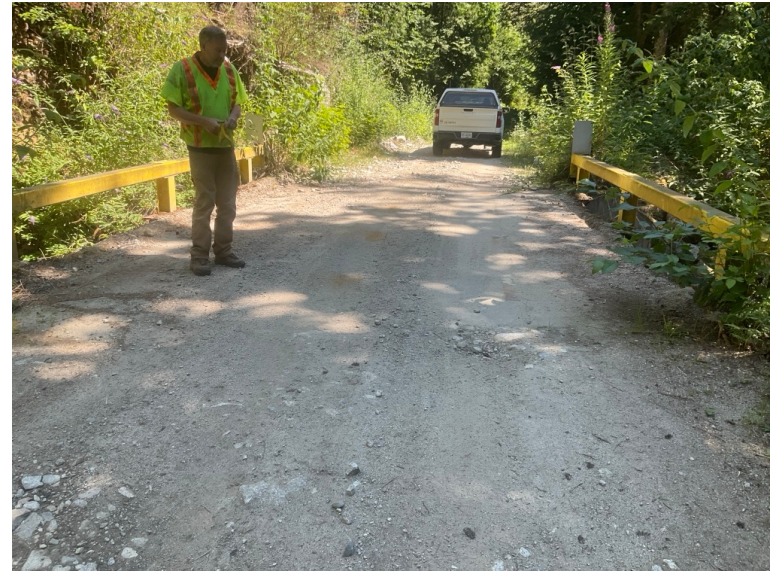
Approach from Right Bank when facing downstream

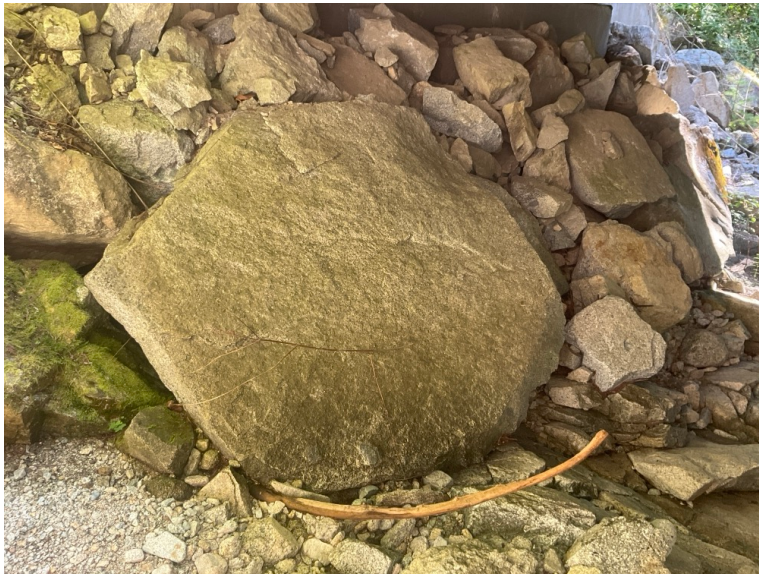
Left Bank Abutment when facing downstream

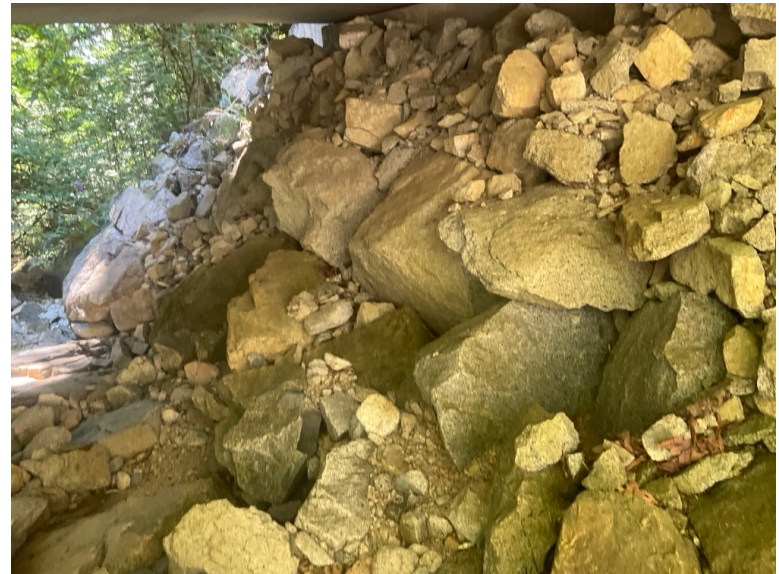
Right Bank Abutment when facing downstream
