SC-8624  
SC-8624

## SECHELT ROBERTS 0.17km

2025 Inspection

Structure Class Temporary Bridge

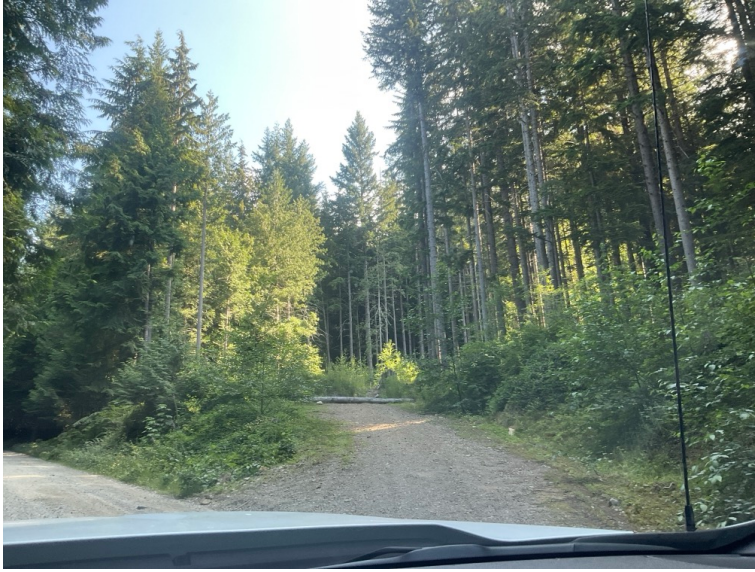
Approach from Left Bank when facing downstream
