SC-8625  
SC-8625

## SECHELT ROBERTS 0.31km

2025 Inspection

Structure Class Temporary Bridge

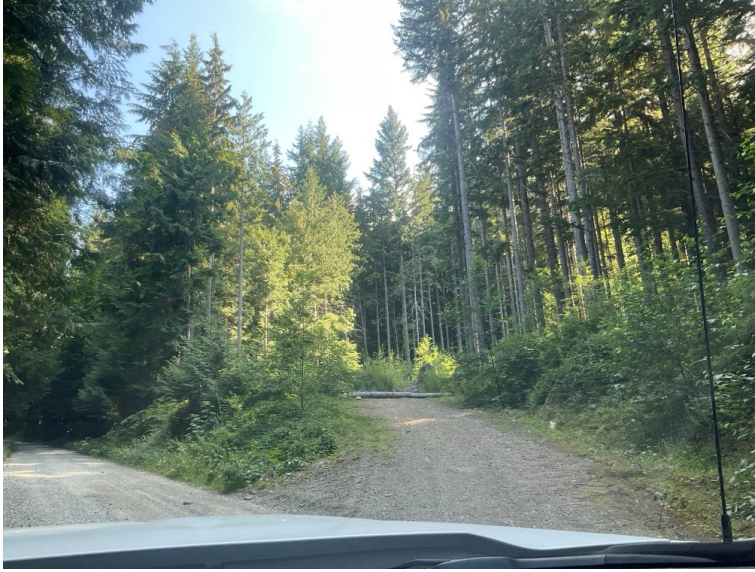
Approach from Right Bank when facing downstream
