SC-8626  
SC-8626

## SECHELT ROBERTS 0.42km

2025 Inspection

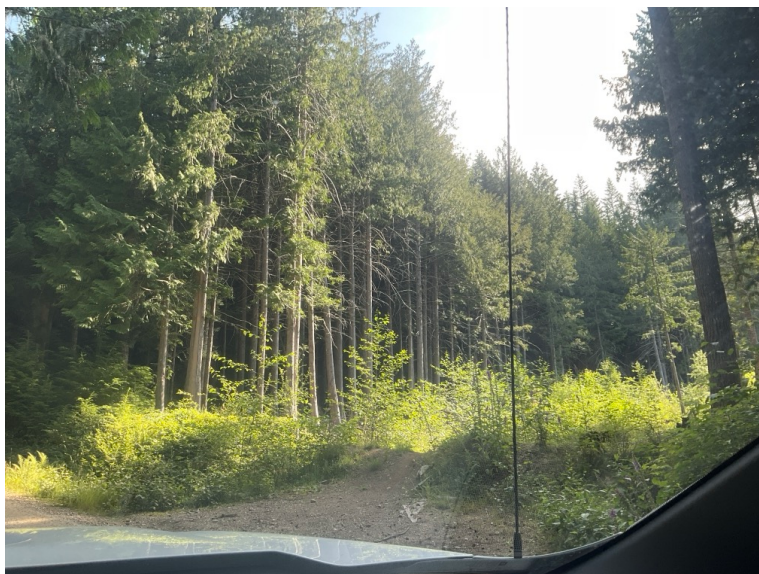
Approach from Right Bank when facing downstream
