SC-8627  
SC-8627

## SECHELT ROBERTS 0.57km

2025 Inspection

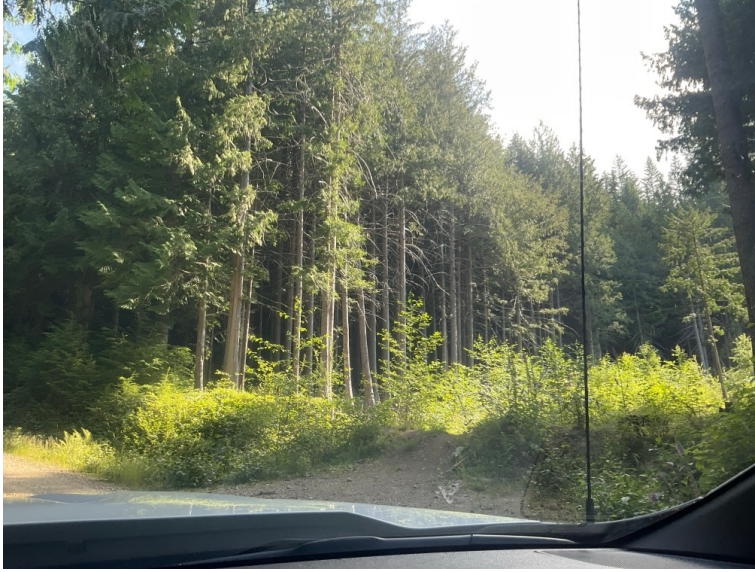
Approach from Right Bank when facing downstream
